IN THE CORONERS' COURT OF THE NORTHERN TERRITORY

CORONERS FINDINGS

ROAD DEATH 22 OF 2024

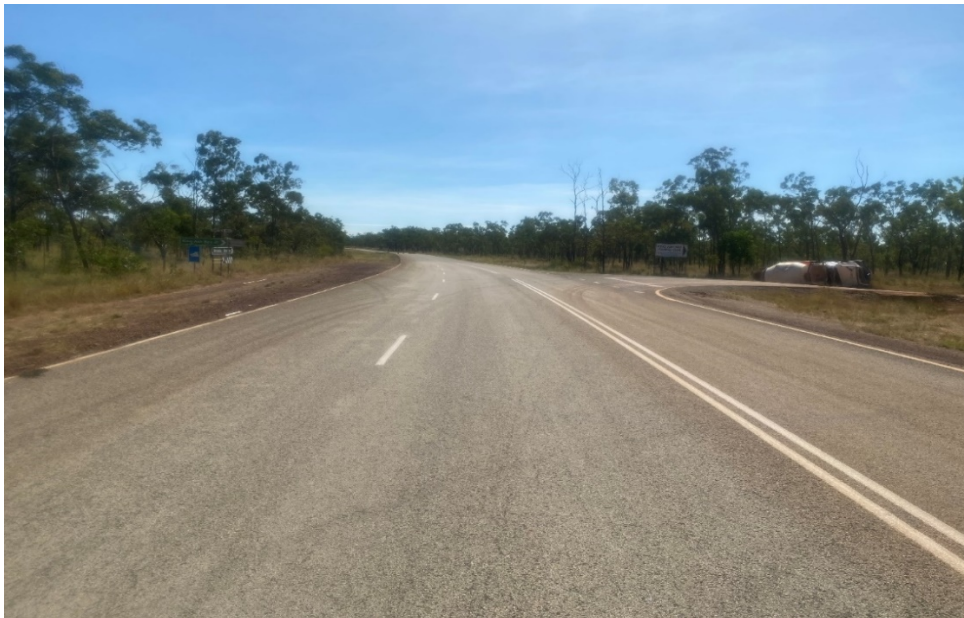
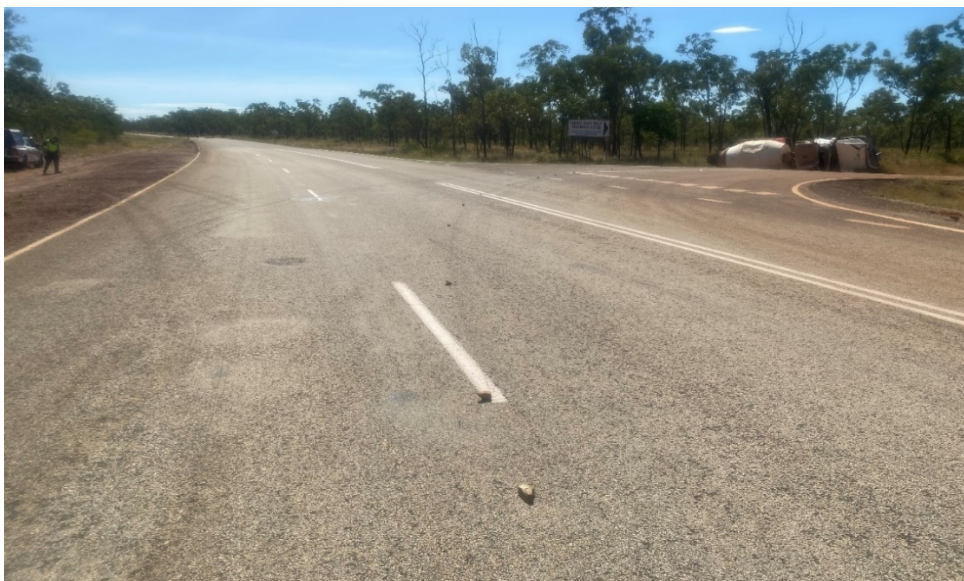
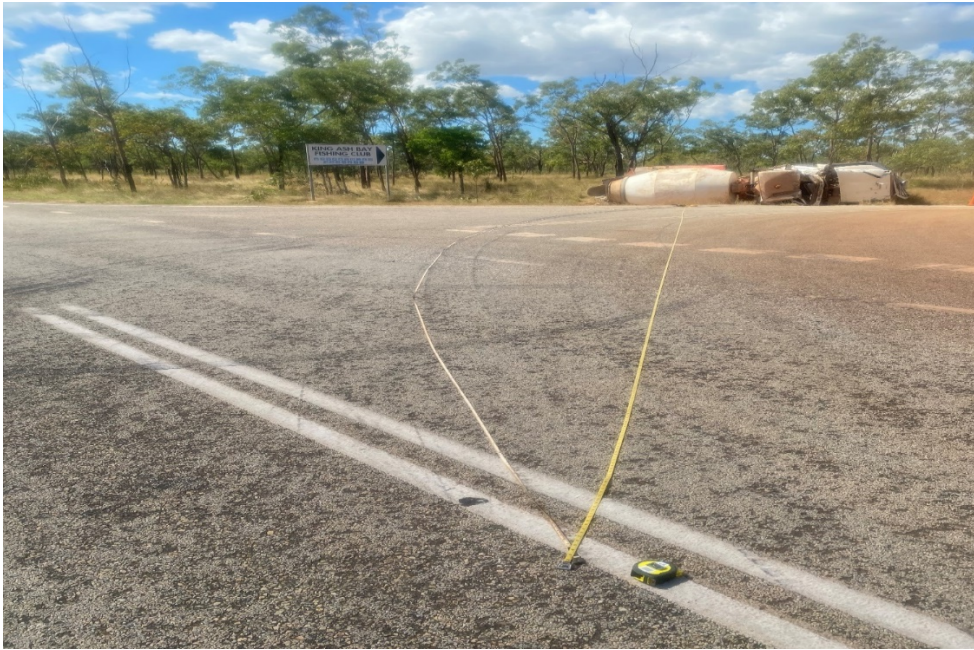
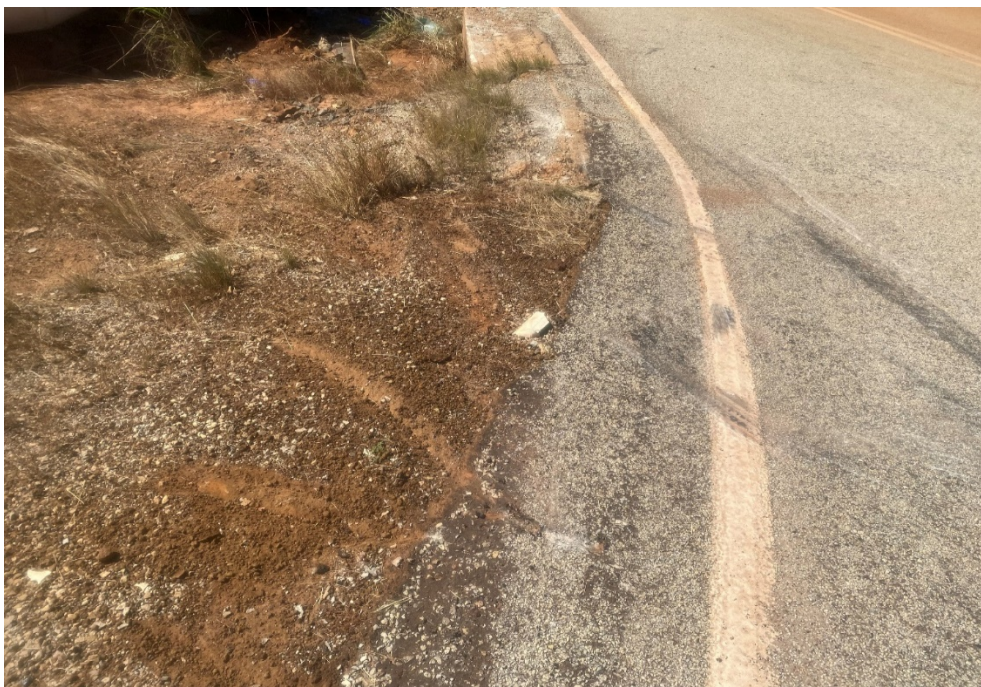
The OIC measured and photographed the yaw marks at the scene. This information was provided to the Major Crash Investigation Unit. From the measurements a speed calculation was completed. The calculated speed the truck was traveling at the time it left the yaw marks is 45.60 kmh.

There is a discrepancy between the speed calculation and the eye-witness estimates of speed which is not easy to resolve. However, it is the investigator's opinion that the truck was traveling too fast for the conditions to safely make the right-hand turn from Bing Bong Road in Batten Road. As the truck travelled through the turn, the right-hand wheels lifted. The

investigator opines that the load of wet concrete likely shifted with momentum, adding an extra force to push the truck over.

The investigator noted that cement agitators by design have a high centre of gravity, even unloaded. When loaded the centre of gravity is fluid making it even less stable. The rotation of the drum, with concrete mix on board, moves the centre of gravity as the mix is pulled up the inside of the drum by internal fins. This can make turning, stopping and uneven terrain more difficult to navigate.
