IN THE CORONERS' COURT OF THE NORTHERN TERRITORY

Rel No: D0211/2024

CORONERS FINDINGS

ROAD DEATH 44 OF 2024

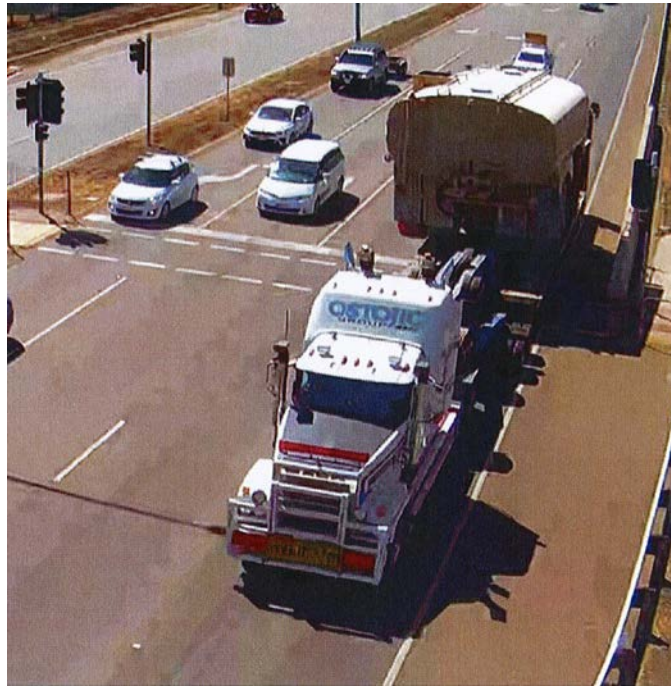
Approximately 1.5 km east of the Humpty Doo Hotel a white escort vehicle carrying a warning sign and warning lights approaching from the opposite direction. The vehicle was an escort for an Ostojic truck transporting a mining water truck from a quarry at Mount Bundy to Darwin as per the conditions of permit D85091.20 The water truck was loaded onto the flatbed trailer facing backwards with the left-hand side of water tanker extending past the width of the prime-mover and trailer.

Image of Ostojic truck on day of the crash

An investigation into the cause of the crash was commenced with statements obtained from EH and other witnesses. The wide load truck and escort were identified through CCTV as belonging to Ostojic Transport. A copy of the permit was obtained, and a scan of the water tanker completed. The maximum width of the water tanker was 4.4 metres, within the 4.5 metre limit specified in the permit.

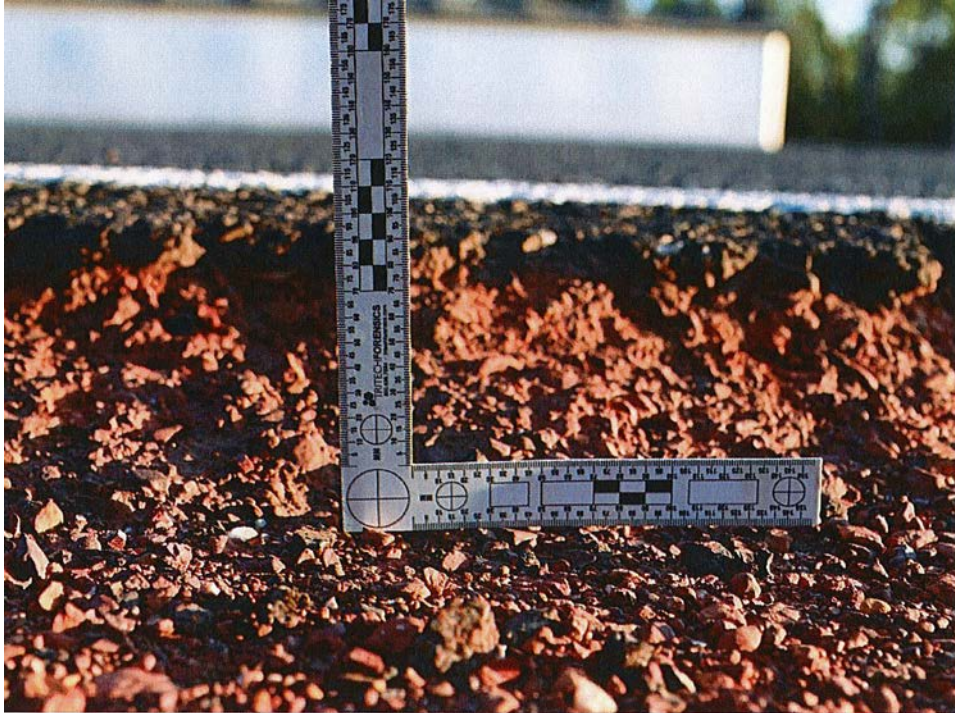
At the time of the crash, Major Crash Investigators noted a drop-off from the edge of the road surface to the dirt shoulder in the vicinity of the crash of up to 100 millimetres (10 centimetres). On 24 September 2024 a Fatal Accident Report Form was completed by a Road Operations Officer from Department of Infrastructure, Planning and Logistics. The drop off was noted on the report however it was deemed to be within safe tolerances.

Drop off from road surface to shoulder (MCIU photo)

The drop-off from the road edge to the shoulder may have been a contributing factor to unsettling the Ford Ranger when it returned to the road surface, however, there is insufficient data and research to make conclusions regarding that theory.

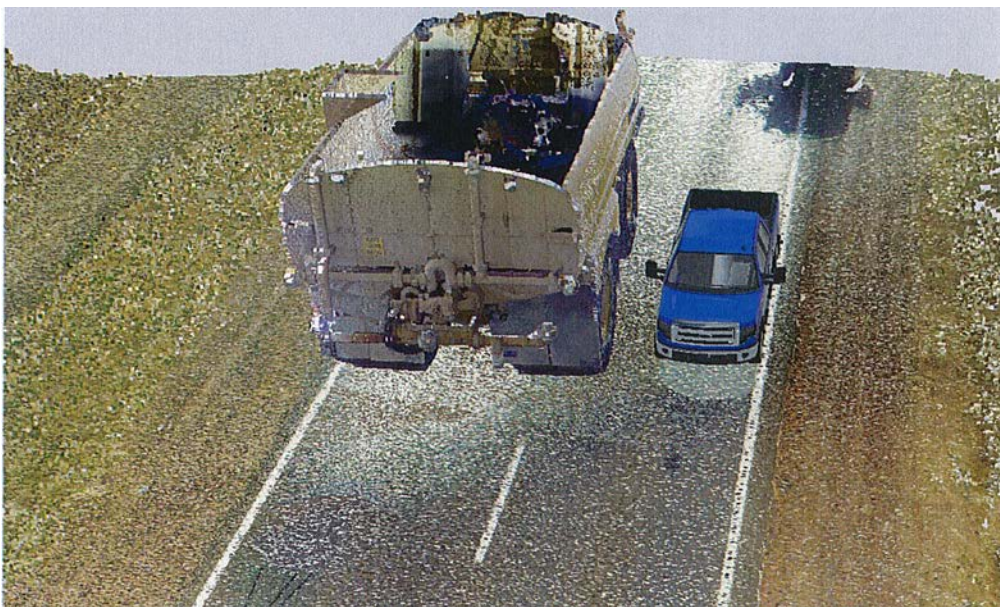
Laser scans taken at the scene and of the Caterpillar water tanker were entered into Faro CAD software to show the estimated positions of the vehicles prior to the crash based on the information provided by witnesses to the crash.

The scan of the Water tanker on the road with its edge inside the inbound fog line and a model of a Ford utility with the same dimensions as the Ford Ranger alongside it was consistent with witness accounts. From the edge of the water tanker to the side of the road there was approximately 2.8 metres, which is sufficient for most vehicles to pass without leaving the road surface.

Water tanker and Ford utility reconstruction (Faro)
