FINDING OF INQUEST

An Inquest taken on behalf of our Sovereign Lady the Queen at Adelaide and Whyalla in the State of South Australia, and Ada, Oklahoma and New York City, New York in the United States of America, on the 22nd July to 5th August 2002, the 26th August to 3rd October 2002, the 23rd to 30th October 2002, the 11th November to 24th December 2002, the 3rd, 29th and 30th days of January 2003, the 14th and 28th days of February 2003 and the 24th day of July 2003, before Wayne Cromwell Chivell, a Coroner for the said State, concerning the deaths of Benjamin Kurt Mackiewicz, Joan Elizabeth Gibbons, Teresa Viola Pawlik, Wendy Ruth Olsen, Peter Desmond Olsen, Neil Marshall, Richard Deegan and the disappearance of Christopher James Schuppan.

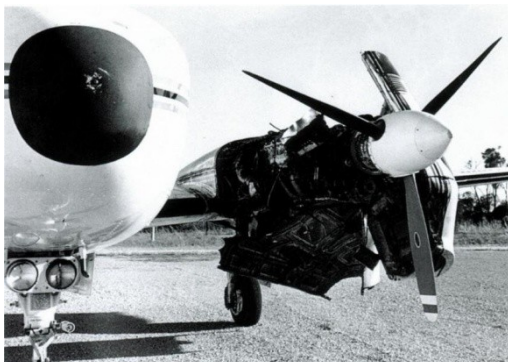
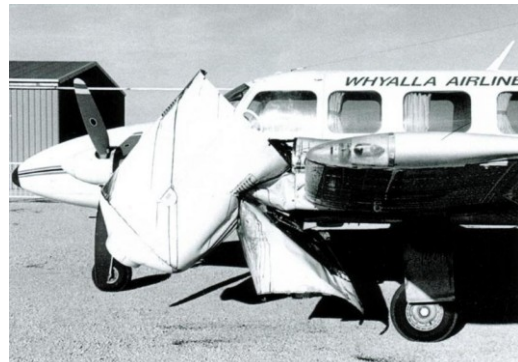
On this day Mr Mackiewicz was the pilot of MZK. He was flying from Cleve to Adelaide when at about 5:35pm the left engine suffered a ‘catastrophic failure’ when the entire front cylinder separated from the engine, along with a section of the crankcase to which it was attached. It was later determined that a failure of the connecting rod to the No.1 piston had failed at the small (piston) end, which in the words of CASA, was attributed to ‘maintenance error’ (CASA Submissions, p6). I have no evidence before me to verify this conclusion. The issue was not examined in detail since the mechanism of the breakdown was completely different from what occurred on 31 May 2000. The separation of the cylinder and part of the crankcase caused severe damage to the engine cowling, which would have created significant drag and made it difficult to maintain height. Reproduced below are pictures taken of the aircraft after the incident (Exhibit C170f):

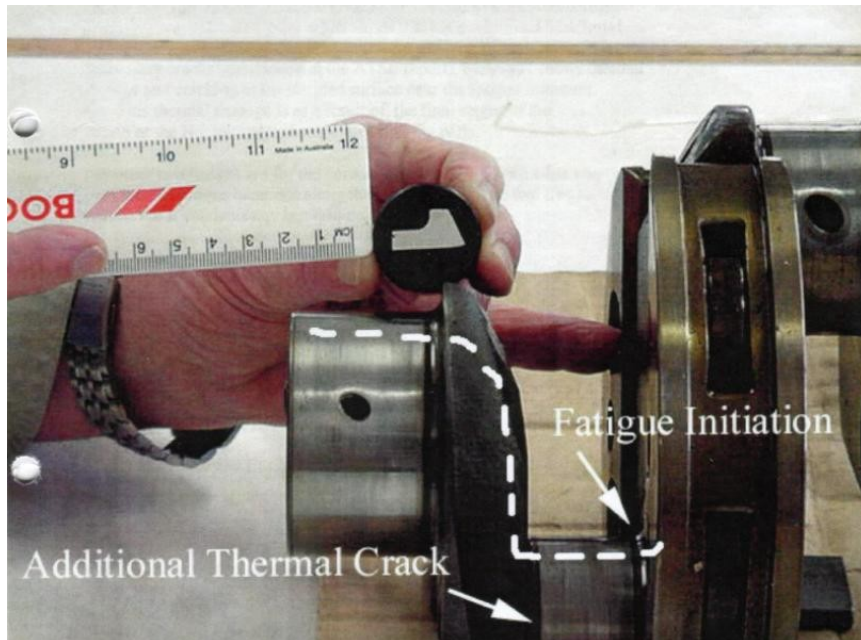
where the sample was taken from the No.5 fillet radius is in the same seam as the point at which the fatigue cracking initiated, as indicated by the white arrow.

12.60. Accordingly, it can be argued that the presence of oxide inclusions in the No.5 fillet radius, as demonstrated by Dr Powell, could lead to the inference that similar inclusions were present at the fracture site. When the fracture site was examined, no such inclusions were found. Dr Powell said that the only way of establishing whether such inclusions were present at the fracture site would be to further test by polishing the fracture site down to the fracture initiation point, which in the process would destroy it (T3409). As I will relate in due course, this testing was subsequently undertaken.

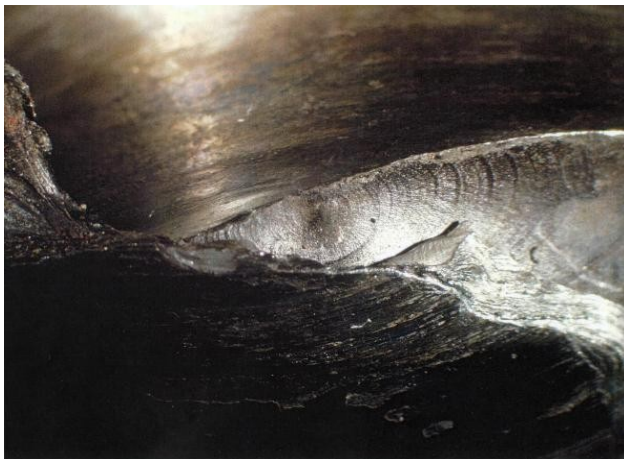
Mr McLean's photograph of MZK crankshaft fracture site
Exhibit C221a

- 12.64. Further, Dr Powell offered the opinion that if the fatigue crack had been initiated by a thermal crack coming down from the surface of the nitrided layer, the appearance of the 'beach marks' would have been different. Photographs taken by Mr Hood (C194) and Mr McLean (Exhibit C221a), clearly demonstrate that the beach marks are of a 'bullseye' configuration, with a small circular defect at the centre, approximately 1 millimetre below the surface. If the fatigue crack had been initiated by thermal cracking, the beach marks would have been 'moon shaped or crescent shaped' coming down from the thermal crack (T3425). The striking similarity of the beach marks in the Sharp Aviation fracture (Exhibit C177f) are illustrated by the following photographs:

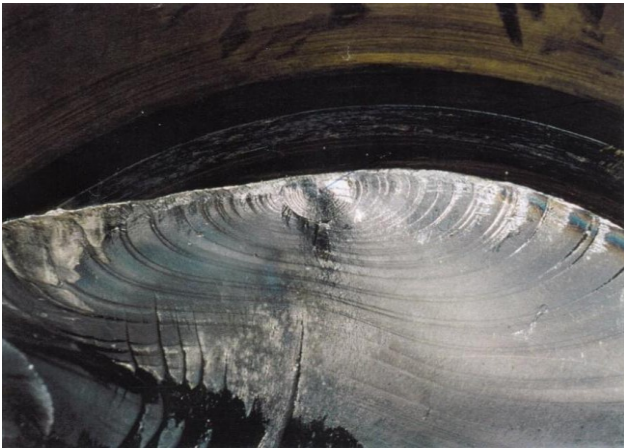
Mr Murphy's photograph of JCH
crankshaft fracture site
Exhibit C177f

- 11.54. The features of the failure of the JCH crankshaft are identical, in almost every respect, with that of the left crankshaft of MZK. The failure happened only five days before the release of the ATSB final report (Exhibit C97), and more than a year after Mr McHardy notified Mr Lyons of CASA that a metallurgical problem had been identified in Textron Lycoming crankshafts in the USA, and a year after an Emergency Airworthiness Directive had been issued in relation to Teledyne Continental crankshafts. Yet the occurrence warranted no more than a 1½-page report,

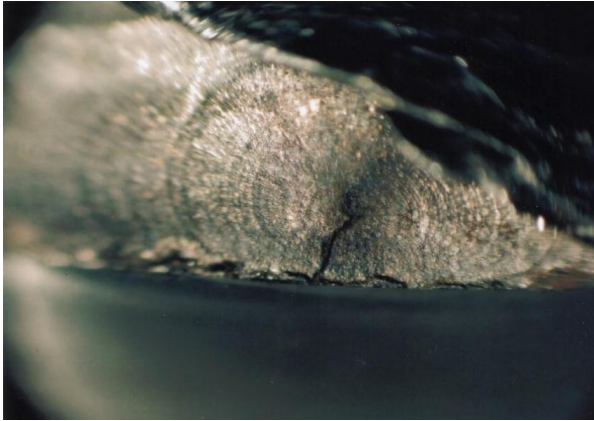
**A**

- 12.112. The SEM photographs (marked A and B in enclosure 3 to Mr Hood's report, Exhibit C194), clearly demonstrated the concentric beach mark rings emanating from a point which Mr Hood described as approximately a millimetre below the surface as well as what he described as a 'tear ridge' emanating from the fracture origin to the surface (T2961). These photographs which so clearly demonstrate the beach marks and the tear ridge are reproduced on the following page:

12.113. Mr Hood said that it was his opinion that the origin of the fatigue failure in the crankshaft of the left engine of MZK was the point demonstrated as being at the centre of the beach marks in the photographs reproduced above, which was ‘subsurface’. He specifically rejected the suggestion that the crankshaft failure was initiated by a heat related crack in the nitrided surface, as suggested by Dr Romeyn and the ATSB (T2963). Using photograph B above, Mr Hood explained:
