FINDING OF INQUEST

An Inquest taken on behalf of our Sovereign Lady the Queen at Adelaide in the State of South Australia, on the 21st, 22nd, 23rd, 24th, 25th, 28th and 29th days of August 2006 and the 18th day of October 2006, by the Coroner's Court of the said State, constituted of Elizabeth Ann Sheppard, a Coroner for the said State, into the deaths of Petrus Jacobus Jong, Helena Alida Maria Jong and Miranda Gertruida Maria Jong.

The said Court finds that Petrus Jacobus Jong aged 56 years, late of Main Road, Forresteron, South Australia died at Morgan Road, Overland Corner, South Australia on the 3rd day of July 2004 as a result of crush asphyxia.

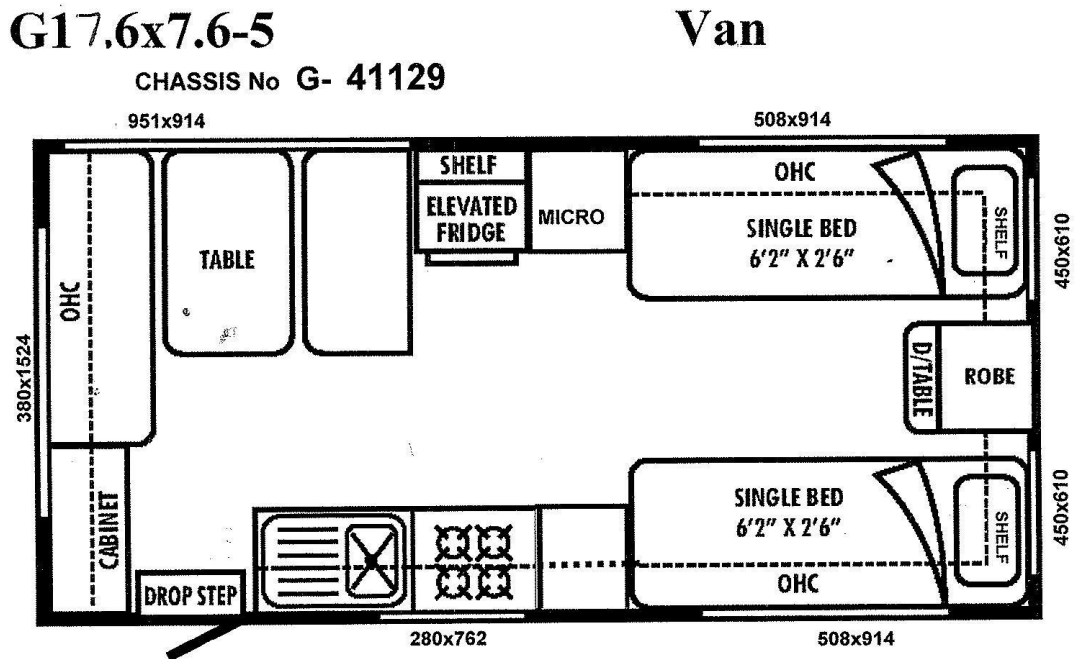
- 1.1. On 2 April 2004, Mr Jong placed an order to purchase a new Galaxy caravan with McKenzie Caravans in Victoria when Mr Jong attended the Melbourne Caravan Show. The contract specified a 17.6 x 7.6 dual axle caravan which was to have a few extra cupboards and a larger table than would normally be present in the standard 16.6

Layout of the caravan ordered by Mr Jong

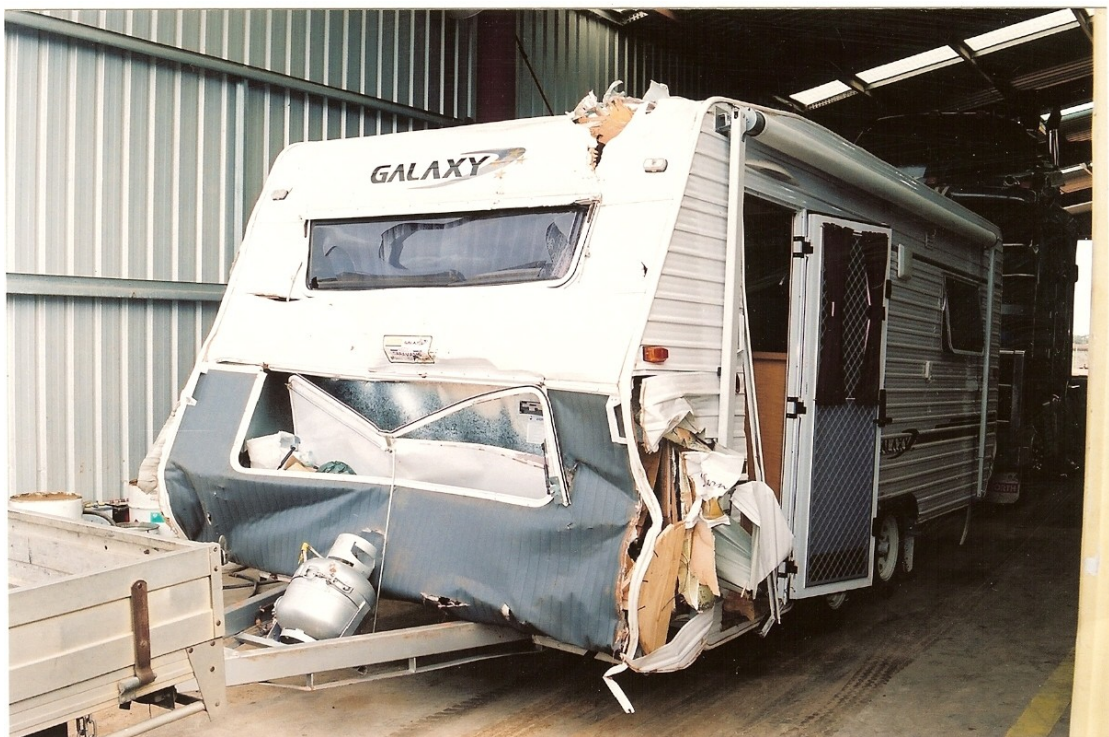
- 6.5. The caravan was also damaged during the collision, with most damage to the front right and left side and draw bar area. The caravan became detached from the Ford Explorer in the course of the collision and continued on in a north westerly direction into the scrub, coming to rest against shrubs and a tree, roughly parallel with the rear trailer of the prime-mover. No investigations were conducted by officers from the Major Crash Unit concerning features relevant to the caravan including whether the jockey wheel was in place at the time the caravan came to rest²⁴. It was not until the Court assembled at Ottoway to view the caravan on the fifth day of the Inquest that it became apparent that the jockey wheel was situated in the boot of the caravan and that the rim of the wheel was distorted in part and the tyre was completely absent²⁵. At no

The damaged caravan as it appeared on 6 July 2004

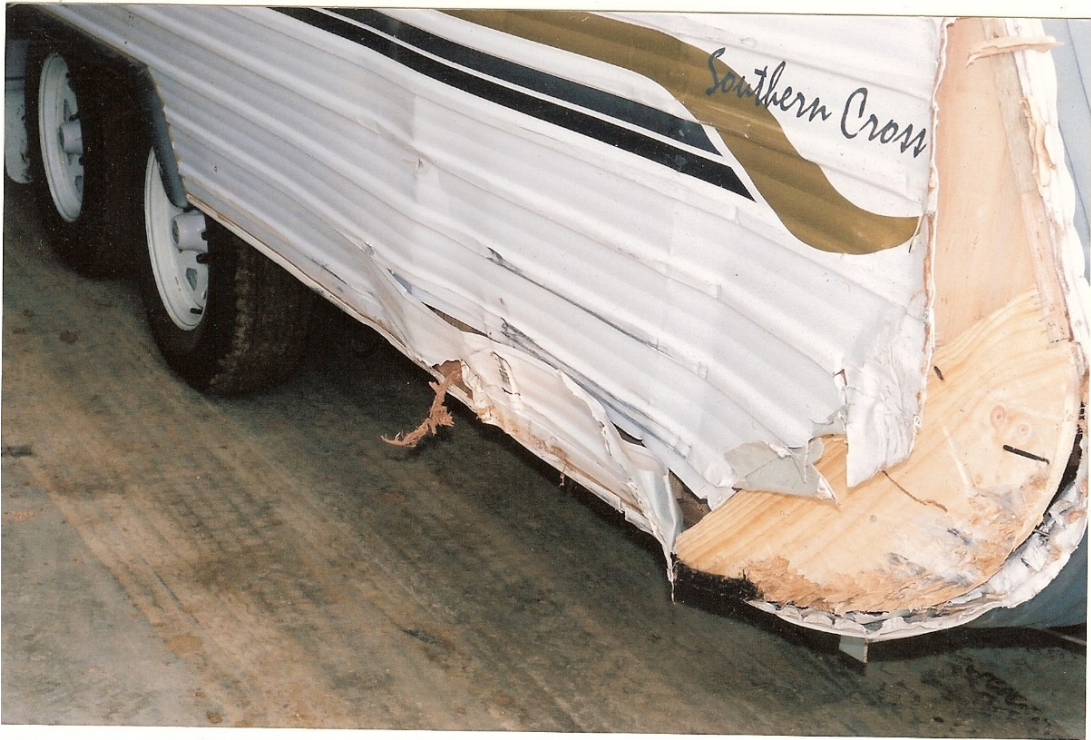
The damaged caravan as it appeared on 6 July 2004

- 6.7. Photographs taken by Christopher Graham on 6 July 2004 depict points of contact between the right side of the caravan and the left passenger side and bull bar of the prime-mover. Another photograph depicts the twisted tow bar and broken safety chains which have severed at approximately mid-point²⁸.

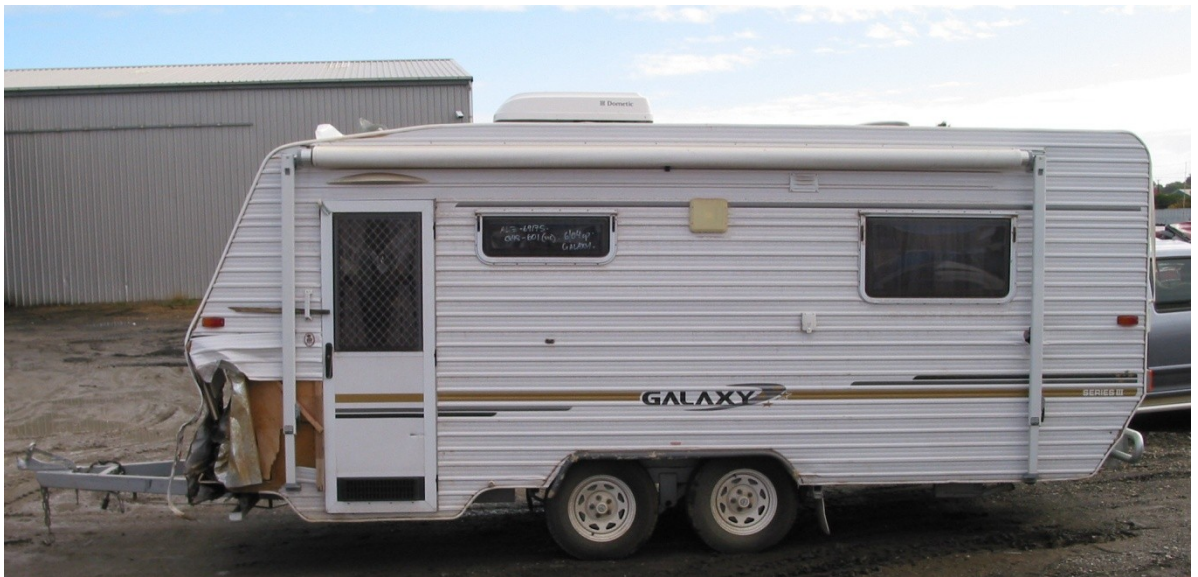
- 7.9. When Mr Olthoff inspected the caravan in June 2005, he was struck by the fact that the empty caravan was horizontal and that the A-frame was unrestricted and unsupported. This observation confirmed his view that the caravan had zero tow ball load as a result of the wheels being 'positioned too far forward in relation to the length of the load carrying area'⁴¹. According to Mr Olthoff, the position of the axles are the prime influence upon the tow ball load⁴². He elaborated as follows:

'The cause of the zero tow ball weight can only be the location of the axle group or axle assembly relative to the length of the body.'⁴³

Photograph taken of damaged caravan in June 2005

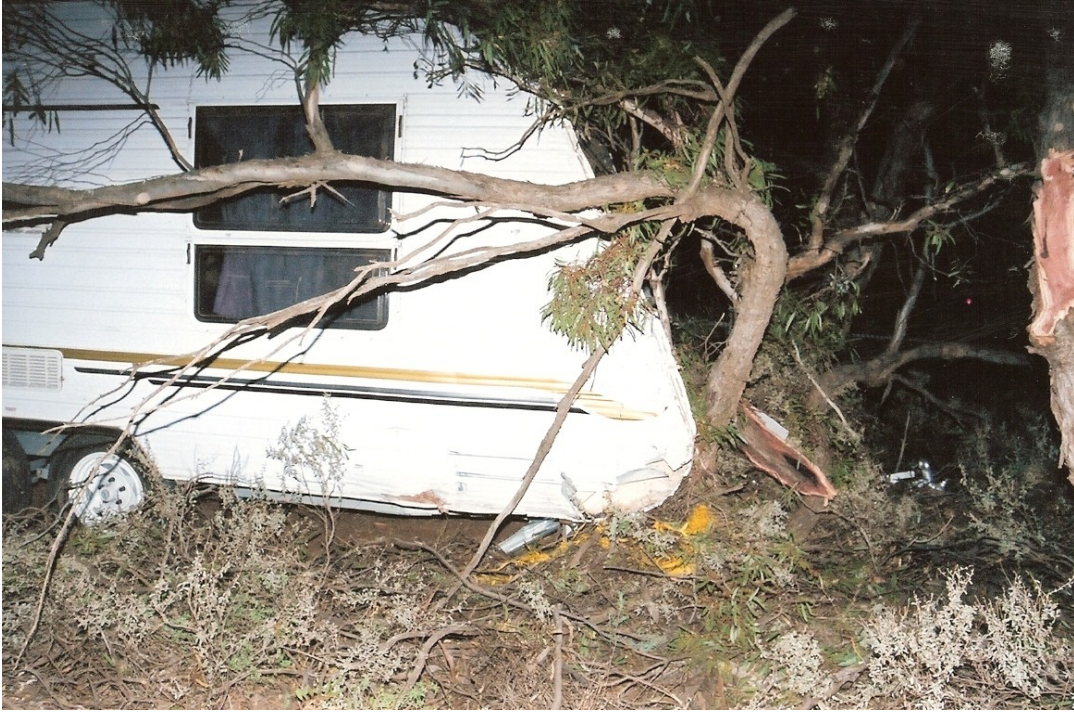
- 10.10. There is no evidence to indicate where the jockey wheel was located after the collision and what condition it might have been in when it was recovered. A photograph depicting the caravan at rest, hard up against the tree in the scrub, suggests an alternative explanation for some of the damage to the front of the caravan, the gas cylinder attachment, jockey wheel and bracket when the caravan travelled through the scrub and struck the tree⁷².

The caravan in the position where it came to rest
