INQUEST INTO THE DEATHS OF
STEPHEN LESLIE ROWE, CHARMAINE TRICIA HUNT,
OLIVIA KATE HUNT AND PETER JAMES FERGUSON

Finding of Inquest - Cause of Death

Inquest conducted by Ms Elizabeth Sheppard, Coroner, South Australia

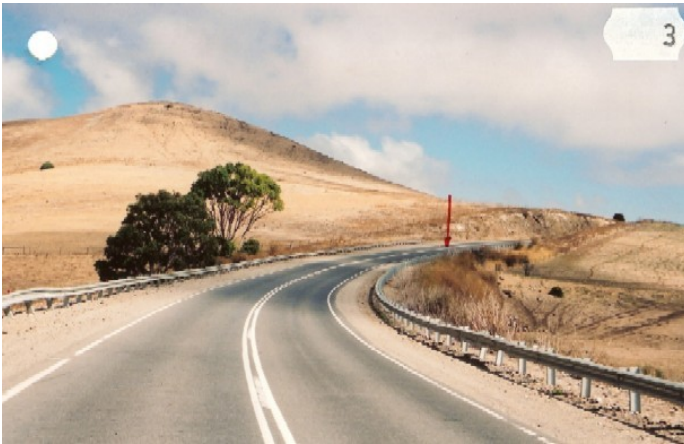
Point of impact for collision 24 May 2000

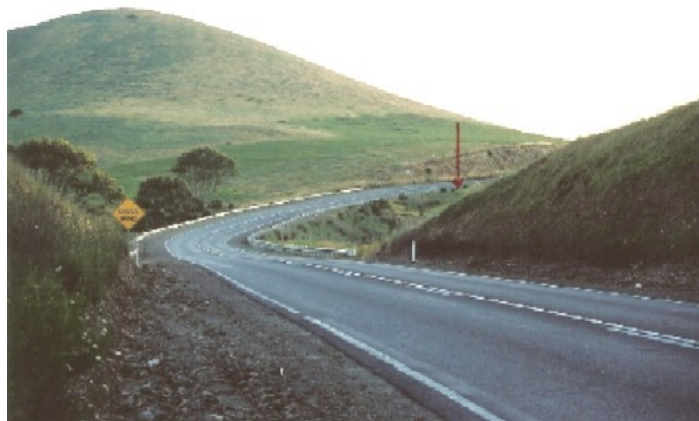
Point of impact for collision 12 November 2001

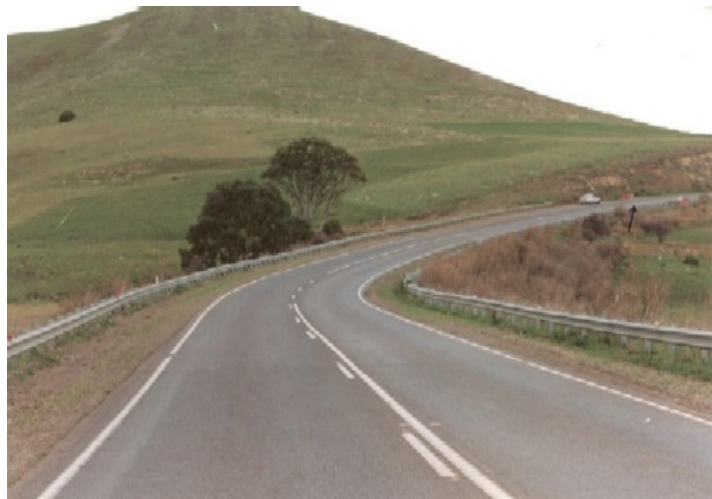
Point of impact for collision 25 March 2002
