FINDING OF INQUEST

An Inquest taken on behalf of our Sovereign Lady the Queen at Adelaide in the State of South Australia, on the 18th and 24th days of December 2020, the 3rd, 17th, 18th, 19th, 22nd, 23rd, 24th, 25th and 26th days of February, the 1st, 2nd, 22nd, 23rd, 24th and 25th days of March, the 28th, 29th and 30th days of April, the 3rd, 4th, 17th, 18th, 19th and 27th days of May, the 15th and 25th days of June, the 6th day of August, the 7th and 9th days of September 2021 and the 7th day of June 2022, by the Coroner's Court of the said State, constituted of Ian Lansell White, Deputy State Coroner, into the death of Adelene Leong Yi Hui.

The said Court finds that Adelene Leong Yi Hui aged 8 years, late of Bukit Baru, 75150 Melaka, Malaysia, died at Women's and Children's Hospital, North Adelaide, South Australia on the 12th day of September 2014 as a result of multiple injuries. The said Court finds that the circumstances of her death were as follows:

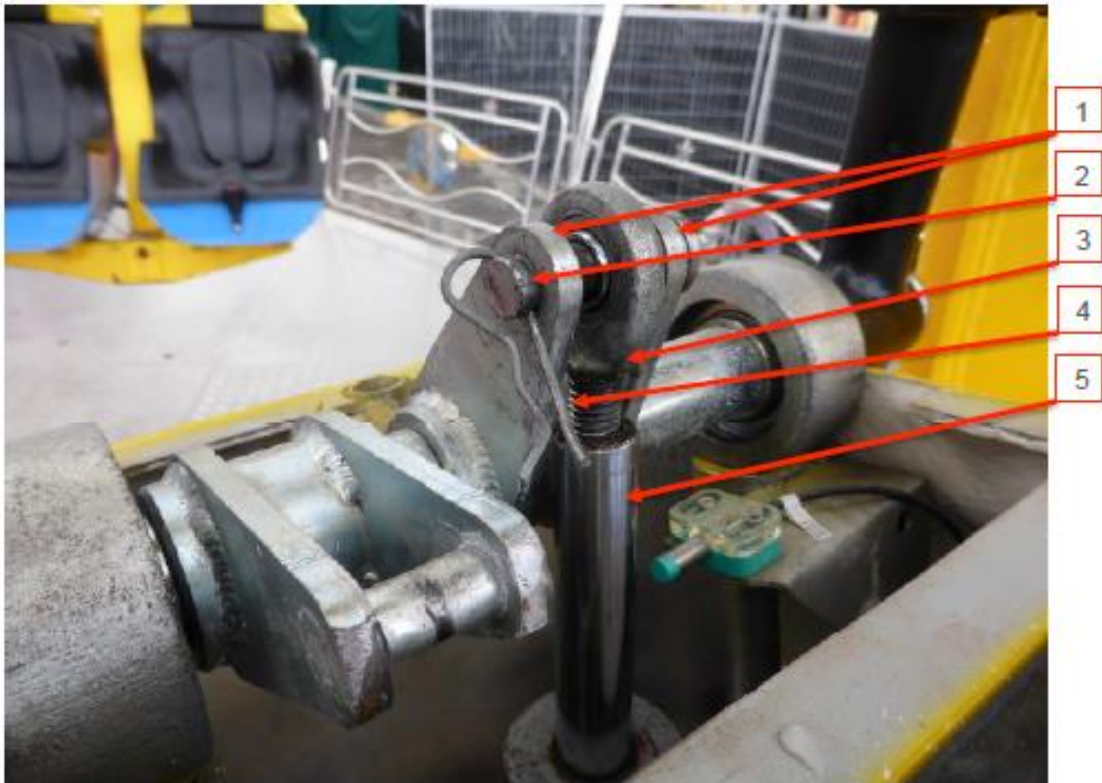
Figure 34 Airmaxx 360 Arm 6 RHS (seat 11) primary lock cylinder connection (P1010540.JPG)

13.27. I insert below the photo²⁹⁴ of Seat 11²⁹⁵ and the PL cylinder as Mr Kroon saw it. It also showed a connecting clip here called an '*R-clip*'²⁹⁶ which is correctly placed to hold the end of the PL cylinder²⁹⁷ in place through the connecting rod.

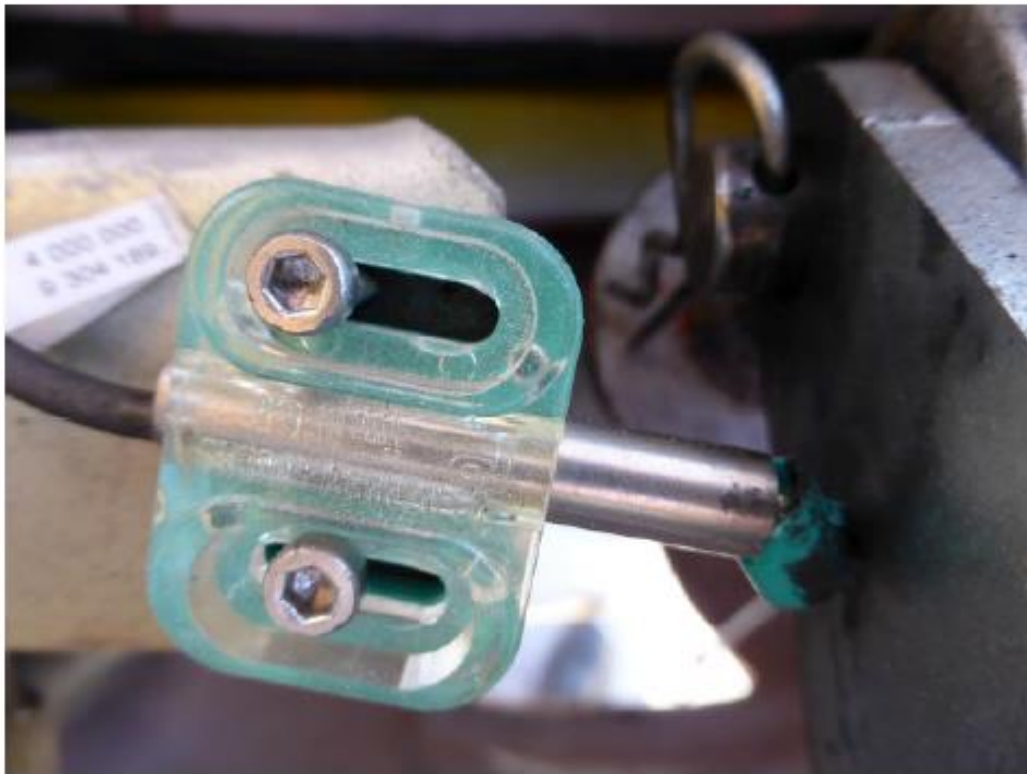
Figure 38 Airmaxx 360 Damaged proximity switch due to contact with R-Clip (P1010459.JPG)

- The R-clip could catch on the sensor and cause the clip to fall out and create the danger of the connecting pins falling out therefore making the PLS ineffective.³⁰⁰

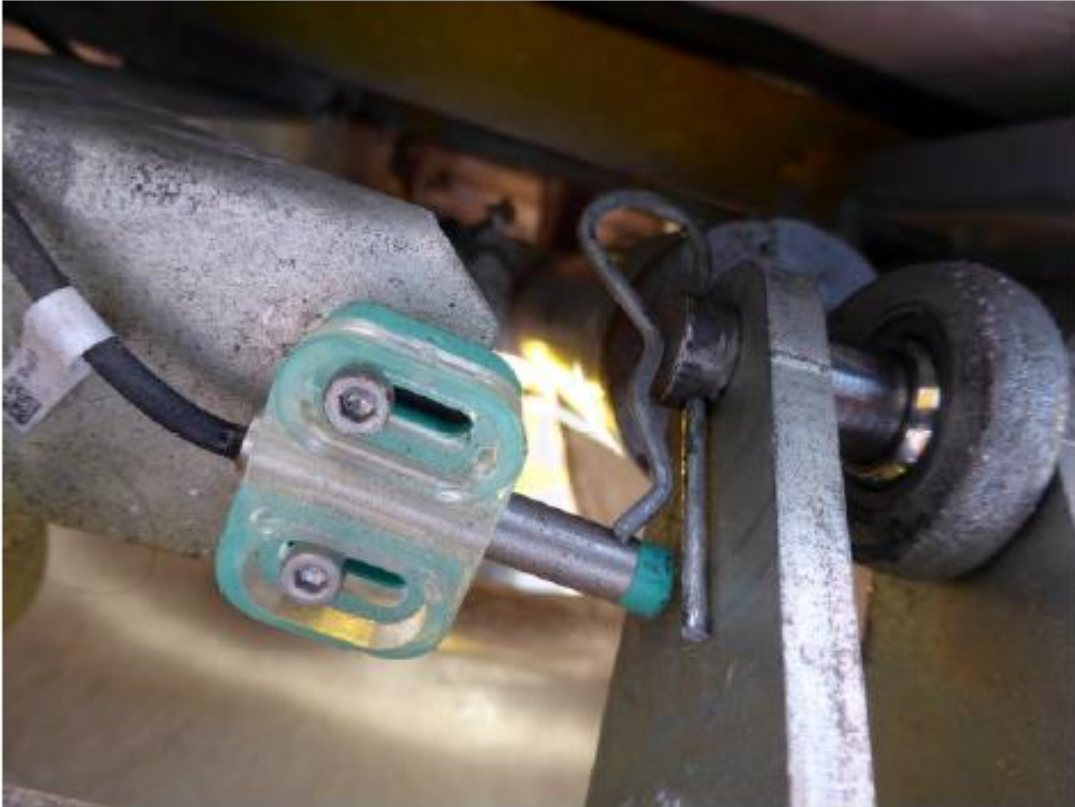
Figure 37 Airmaxx 360 R-clip contacting proximity switch (P1010402.JPG)

There are three significant issues with this:

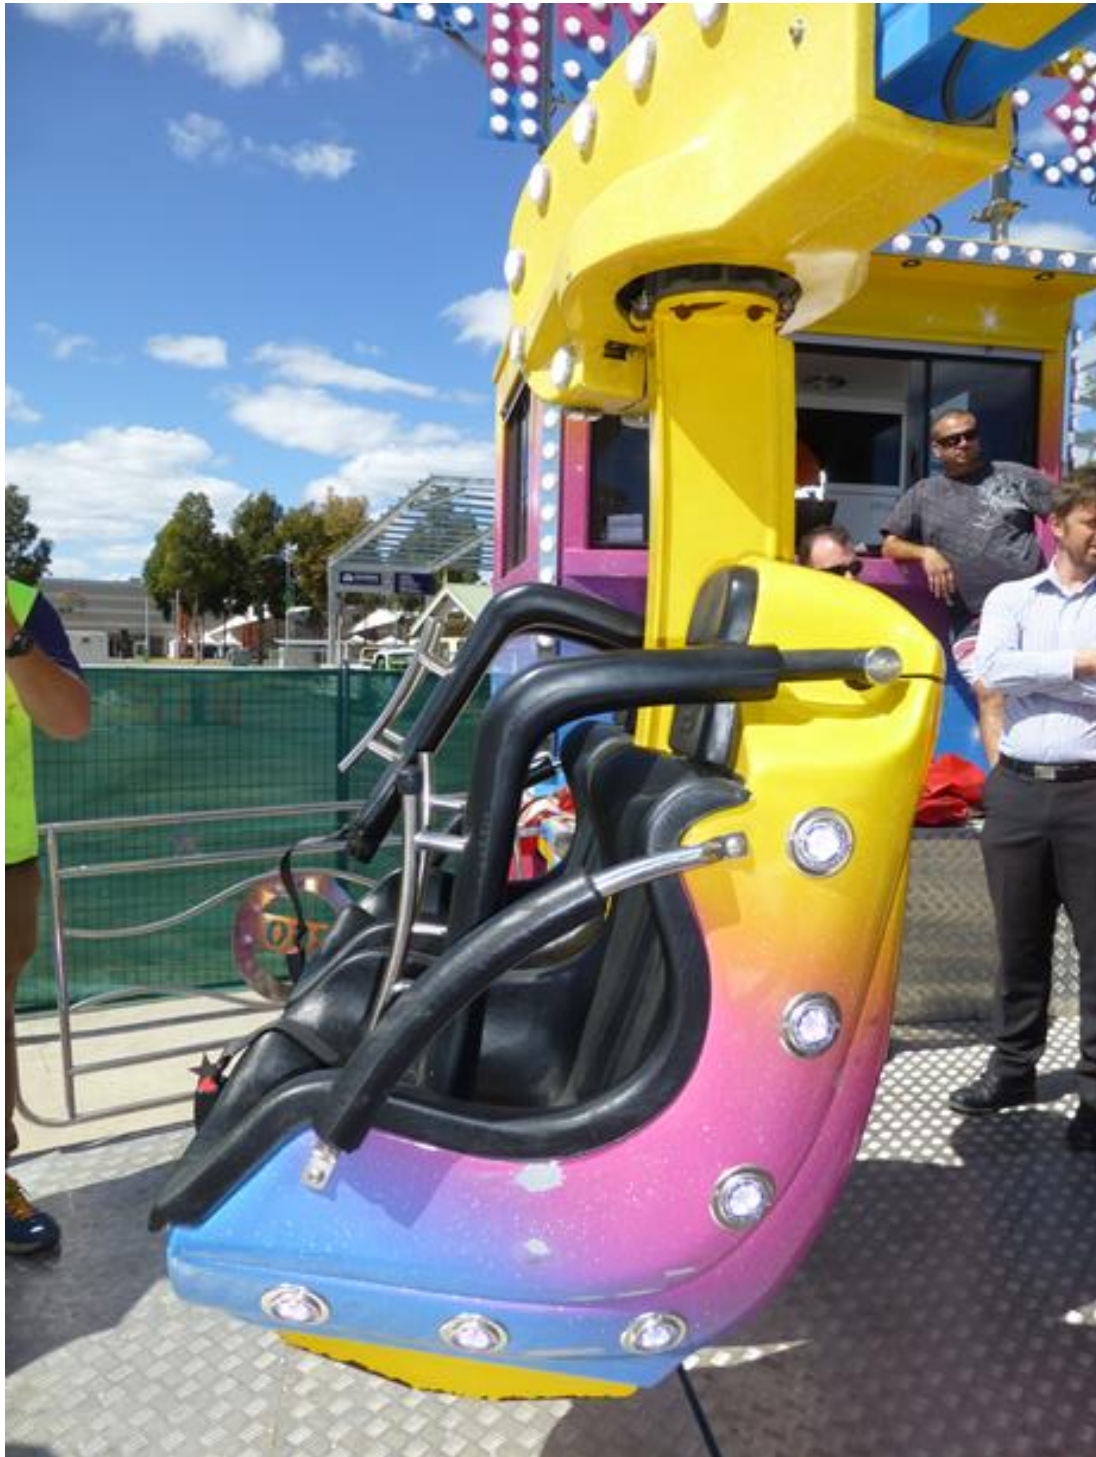
Photograph No.	18	Negative or Image No.	P1010278
Taken by	A McCallum	Company	C, J & Sons Amusements Pty Ltd
Taken on	19/09/2014	Address	Airmaxx 360 location - Royal Adelaide Showgrounds
Infonet File	2014-6302	Description	View from left side of carriage on arm 8. Right hand seat restraint located at the position that the sensor is detected in the control booth.

13.38. These photos show the considerable space and gap that was available for her seat to be considered as lowered by the PLC.

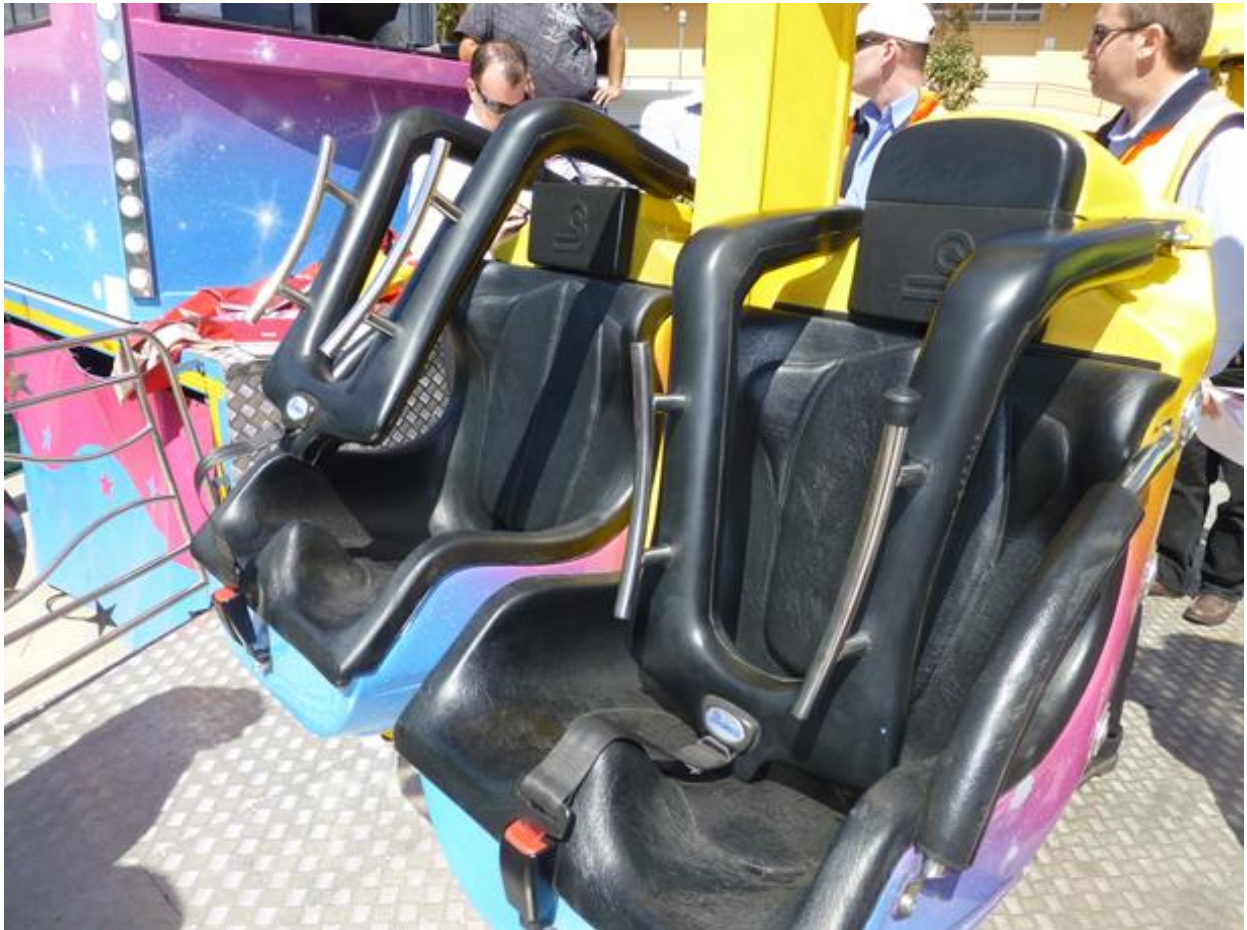
Photograph No.	19	Negative or Image No.	P1010279
Taken by	A McCallum	Company	C, J & Sons Amusements Pty Ltd
Taken on	19/09/2014	Address	Airmaxx 360 location - Royal Adelaide Showgrounds
Infonet File	2014-6302	Description	View of carriage on arm 8. Right hand seat restraint located at the position that the sensor is detected in the control booth.

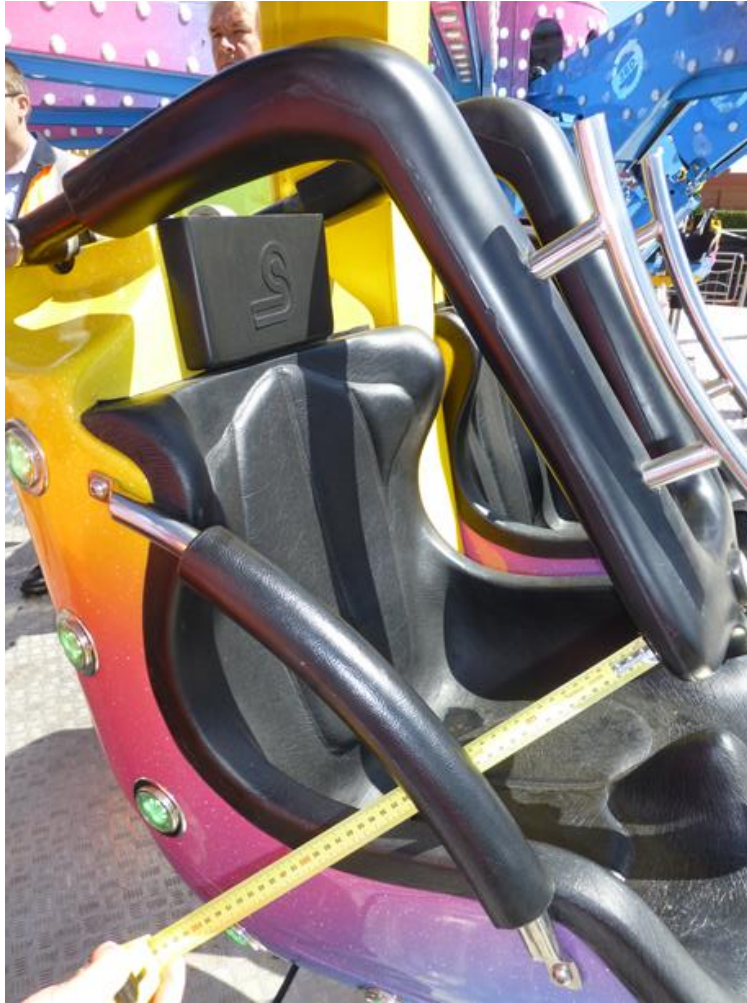
Photograph No.	20	Negative or Image No.	P1010280
Taken by	A McCallum	Company	C, J & Sons Amusements Pty Ltd
Taken on	19/09/2014	Address	Airmaxx 360 location - Royal Adelaide Showgrounds
Infonet File	2014-6302	Description	Measurement of clearance (150mm) from restraint to right hand arm frame of right hand seat of carriage 8 when sensor is detected.

13.39. The comparison between her seat and the other one in these photos is obvious. Photo 18 was basically taken on the same angle as Adelene's mother's photo taken just after Adelene's ride began.³¹² The position of the harness in these photos was not safe for an active ride.

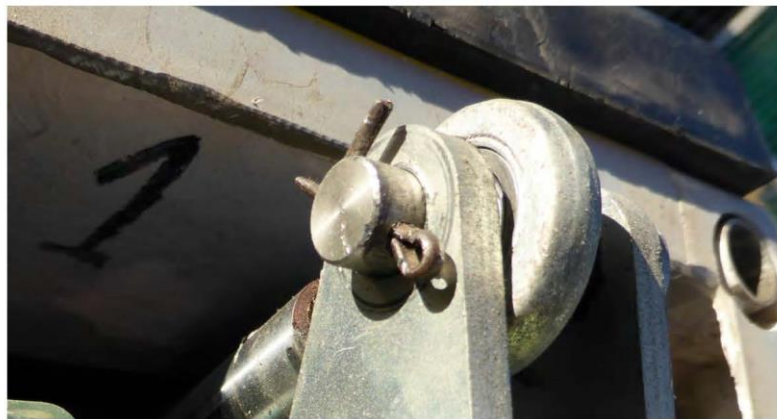
Figure 39 Airmaxx 360 Damaged split pin (P1010479.JPG)

This was the other means of fastening the connecting pin, see Figure 39 below. They were used on 19 seats. Split pins are only to be used once. That is, if they are withdrawn from the connection point, they must be replaced. Some of the split pins were in poor condition and had been reused.

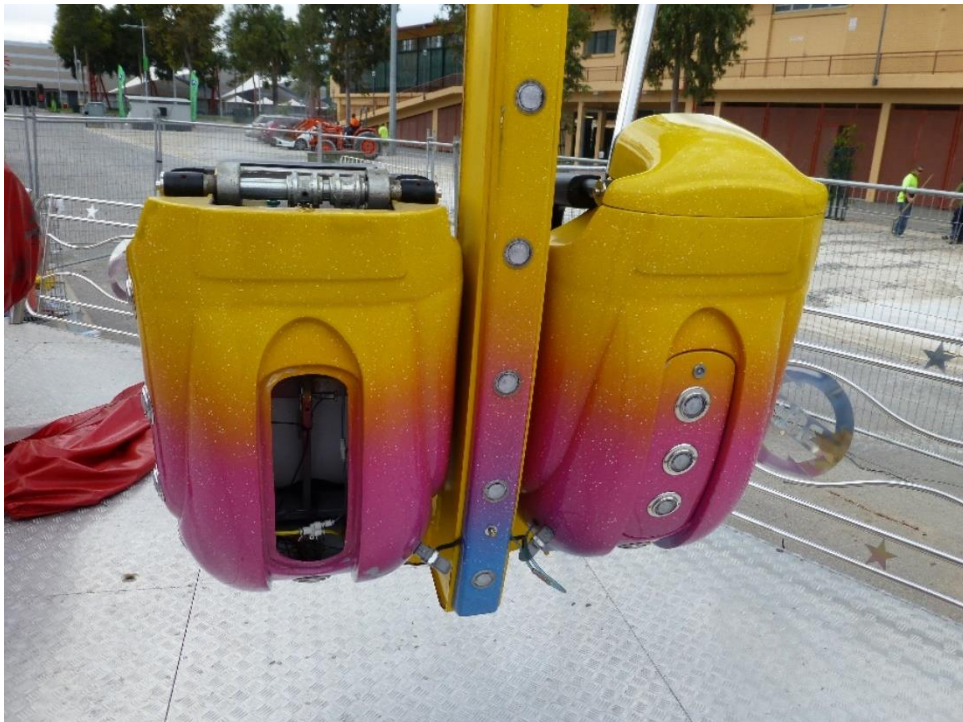
Photograph No.	2	Negative or Image No.	P1010520
Taken by	A McCallum	Company	C, J & Sons Amusements Pty Ltd
Taken on	10/10/2014	Address	Airmaxx 360 at Royal Adelaide Showgrounds
Infonet File	2014-6302	Description	Arm 3 carriage - cover removed on left hand seat.

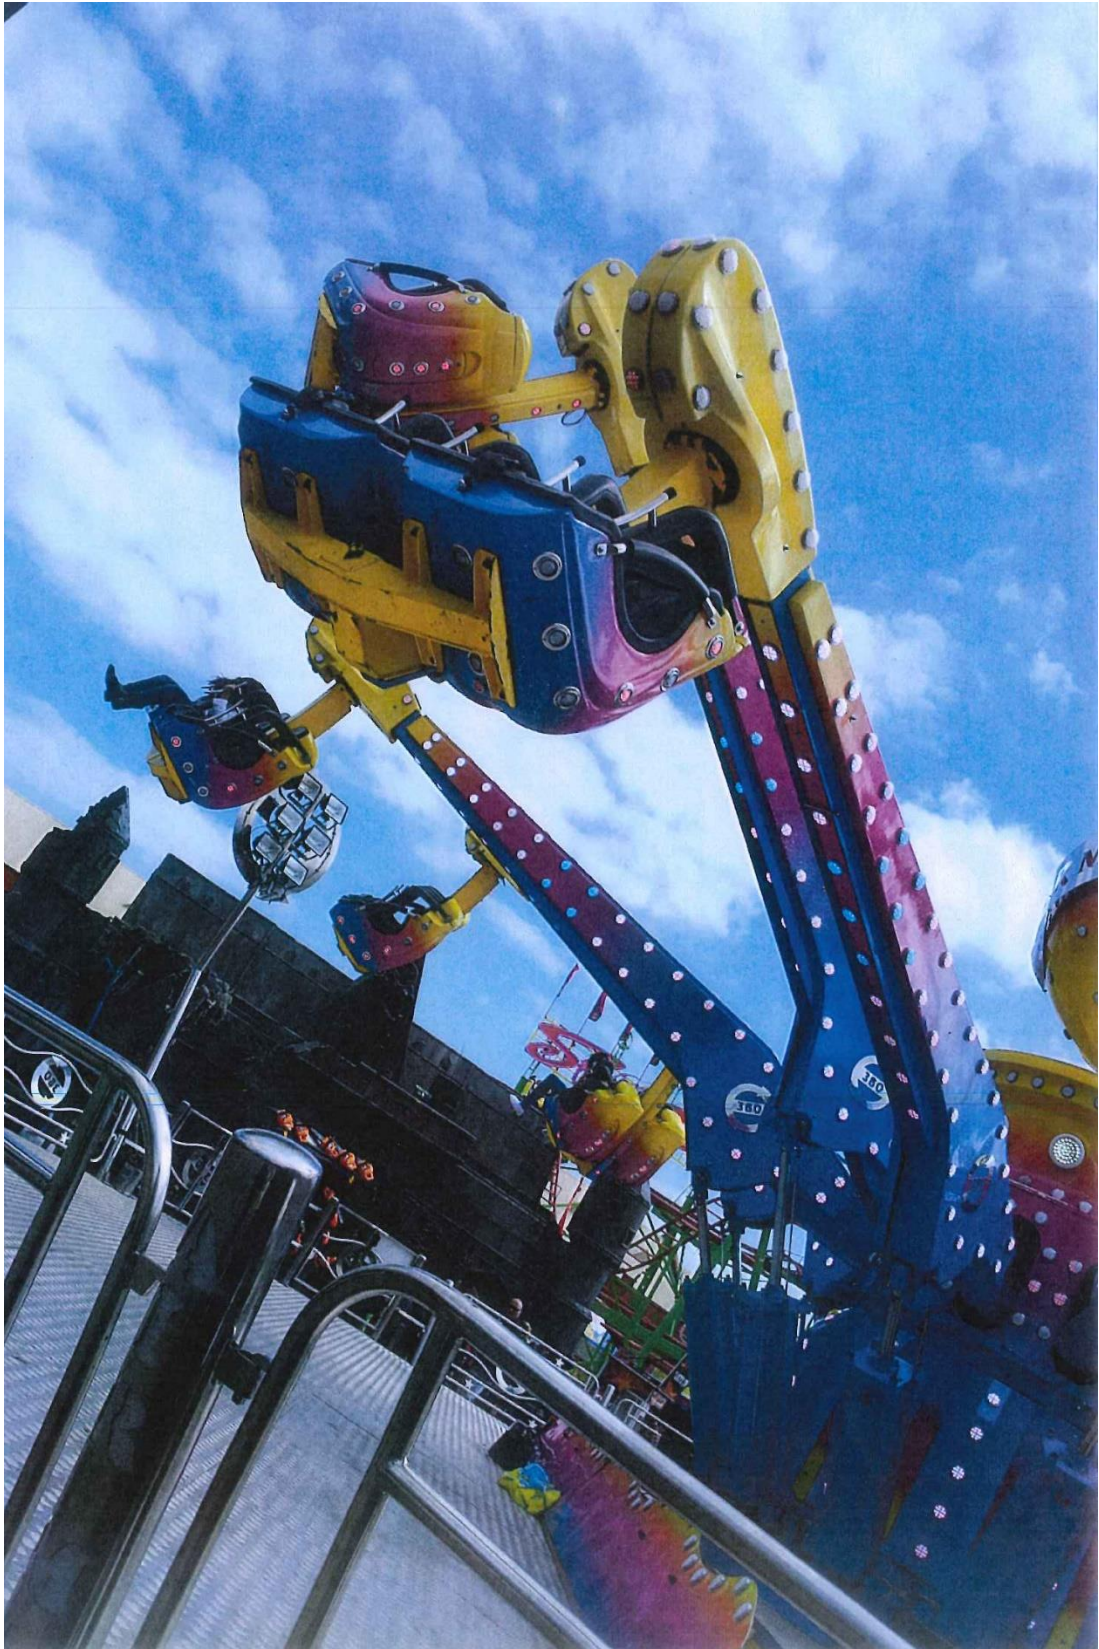
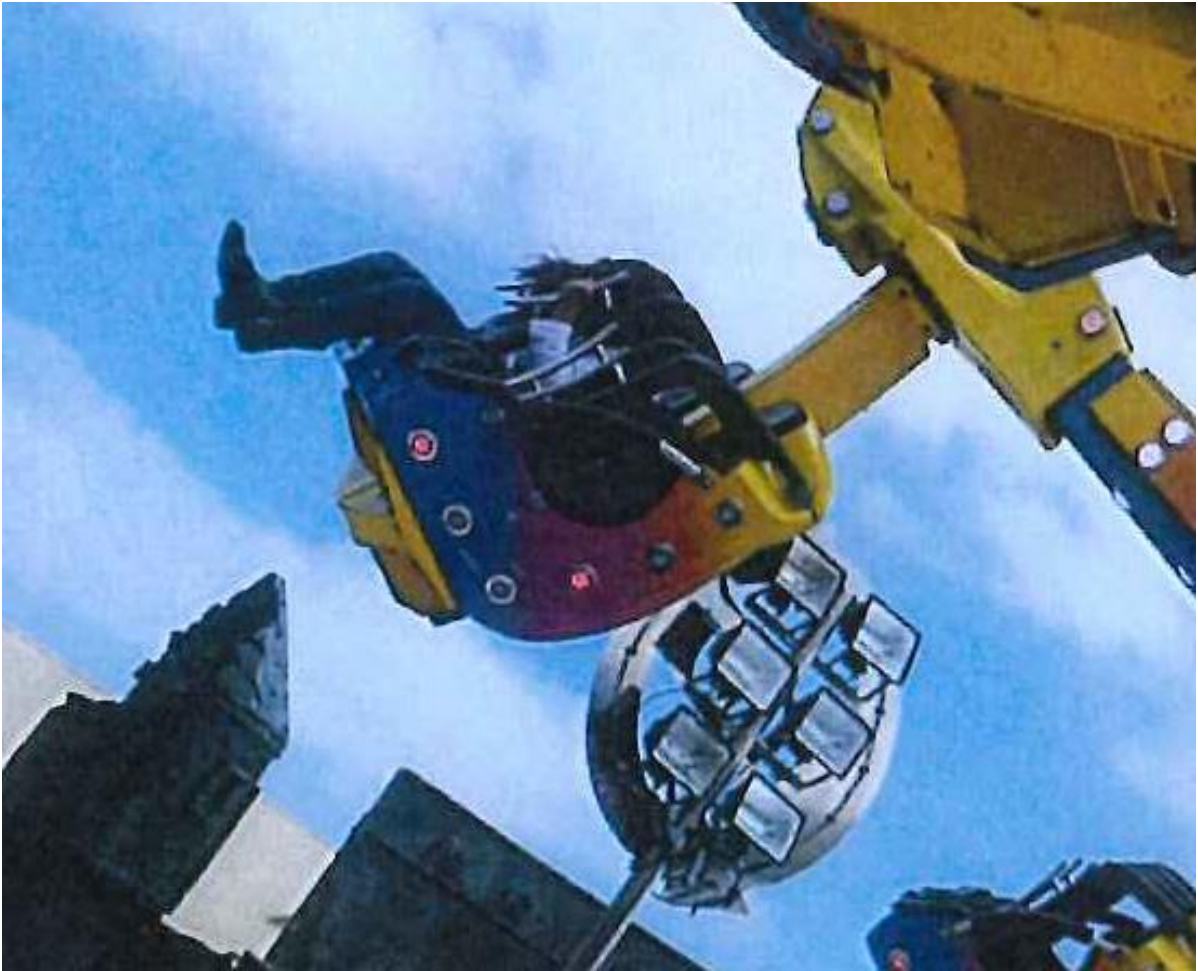
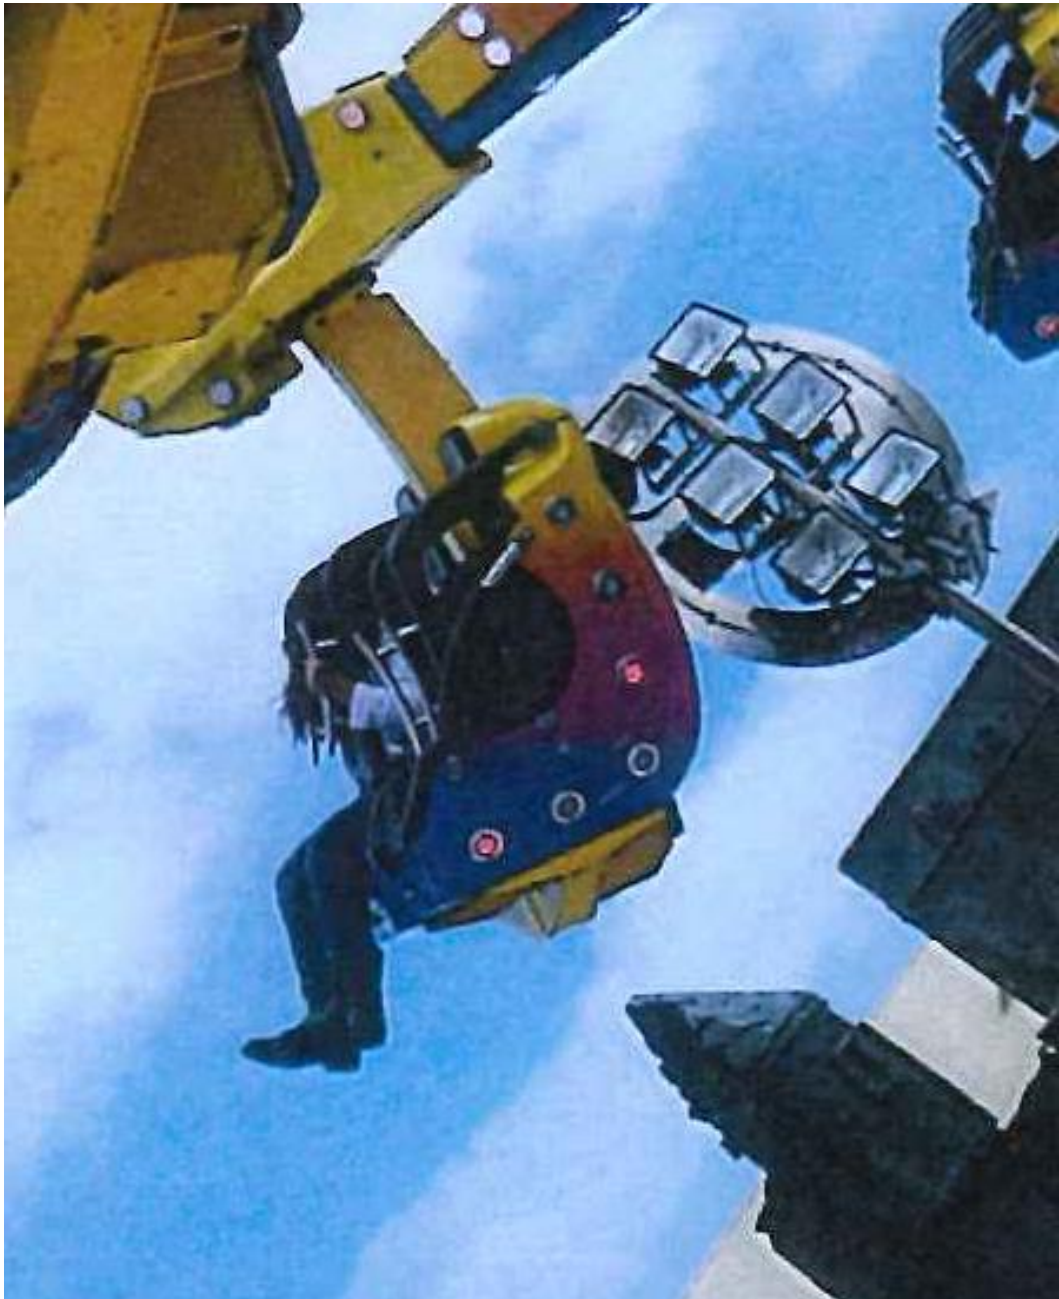
17.12. From those 34 witnesses I wish to highlight two in particular. Before doing so I will insert Adelene's mother's photograph taken just after the ride started. This will help crystallise the descriptions, particularly with respect to Adelene's position in her seat and the state of the harness. I will then set out the analysis of this photo by Mr Kroon.

- 'Q. What suggests to you about that; that that harness is not properly locked.
- A. The angle of the handles appears to be too much - seems to be too much angle on that handle. So even when you compare it to the seat next to her, which is obviously lowered. There's a significant difference in the angles. And I'd say that, from what I
