# MAGISTRATES COURT *of* TASMANIA

## CORONIAL DIVISION

### **Record of Investigation into Death (Without Inquest)**

I, Madeleine Wilson, Coroner, having investigated the death of William John Dick

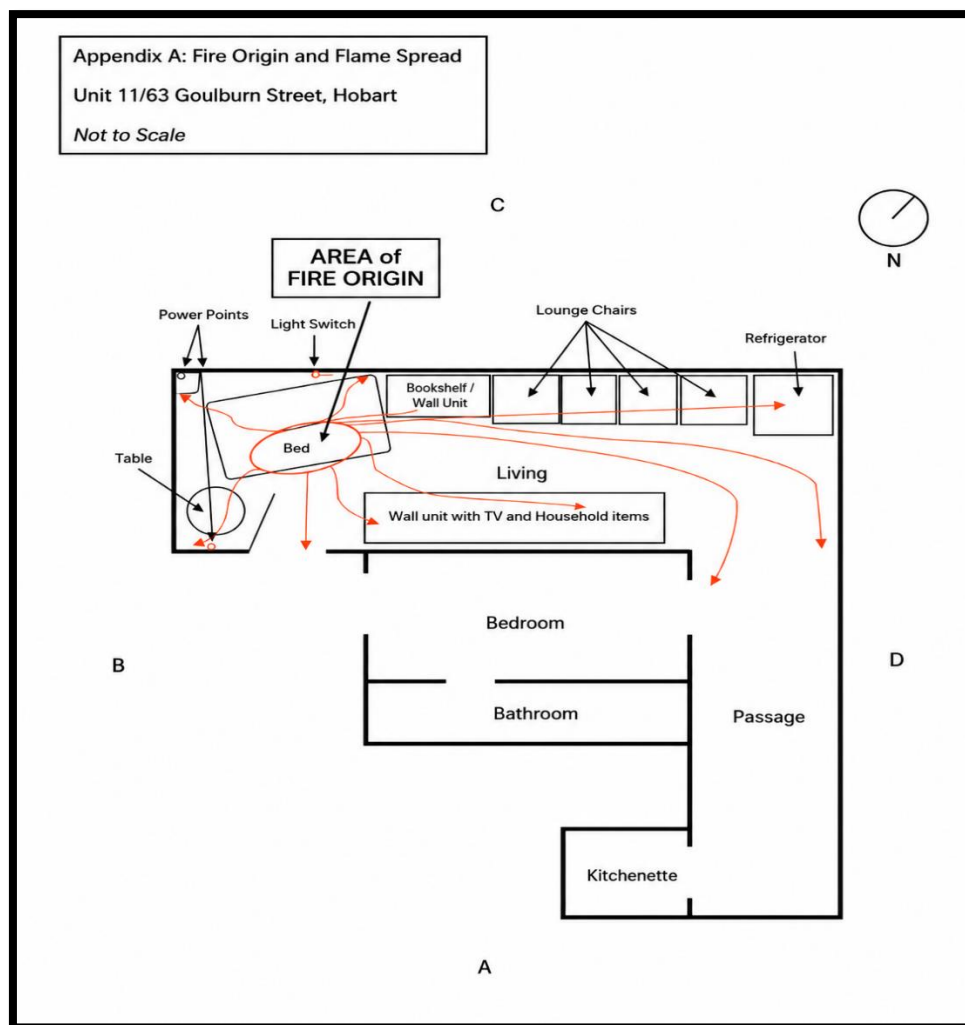
An internal examination of the unit identified numerous fire effects and indicators, which demonstrated greater mass loss and consumption by fire of combustible materials in the area of and immediately around the bed, with thermal damage decreasing in extent and severity away from that area. This was consistent with burning of a longer duration in the area of the bed and mattress.

Prominent flame vector patterns of calcination and clean burn to internal walls and ceiling were consistent with fire emanating from the mattress and spreading from there to throughout the living area.

In Mr McKay's opinion the fire effects and patterns, in aggregate and individually were consistent with fire emanating from the bed located immediately inside the entry door to unit 11.

Mr McKay reproduced a plan of the unit showing the area of fire origin and flame spread.

Based on his detailed scene examination and the fire damage dynamics and observable physical fire indicators, as well as information gained from his investigation, Mr McKay identified a single area of fire origin within the main living area of unit 11, located on the ground floor of the building. In his opinion, which I accept, ignition first occurred on the mattress of the bed located inside the front door to the unit.
