**FINDING INTO DEATH WITH INQUEST**

**Inquest into the Death of NATHAN LINDSAY PARK**

Place of death: 83 Queens Road, Melbourne<sup>1</sup>, Victoria 3182

Findings of: AUDREY JAMIESON, Coroner

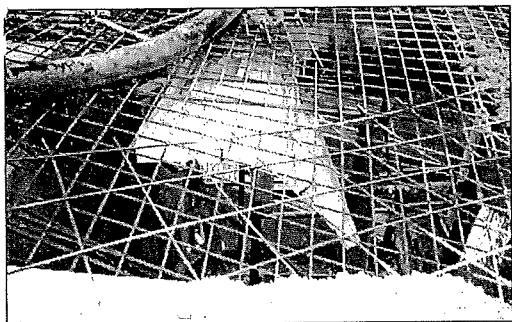
Twenty-three year old Nathan Park was killed when a beam smashed down on him, after a concrete pour caved in at a Queen's Road job in Windsor on September 30.

Above: The Windsor incident where Nathan Park was killed.

An Ultrafloor band beam system was being used at the time.

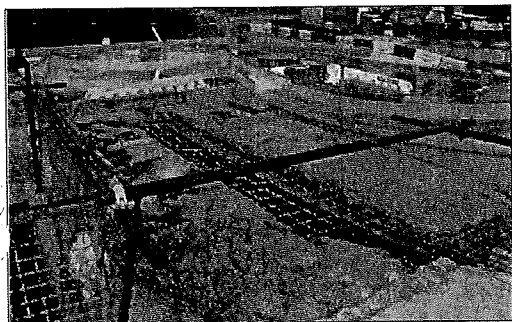
Below: the collapse of the Ultrafloor system at Glebe, Sydney during a cement pour.

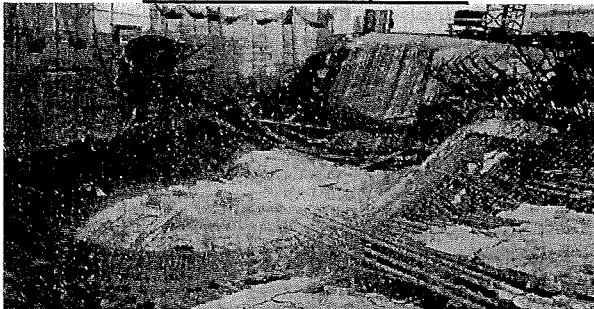
#### Accident # 1 – 23 April 2001

The accident occurred at a 6 storey industrial building with a vehicular ramp. Prior to the accident, level 1 to level 4 of the vehicle ramp had been constructed.

Investigation revealed that the lack of diagonal bracings, inclined support, discontinuity in the structure and use of defective, corroded and deformed members used had reduced the loading capacity, stability and rigidity of the formwork structure. This resulted in its failure.

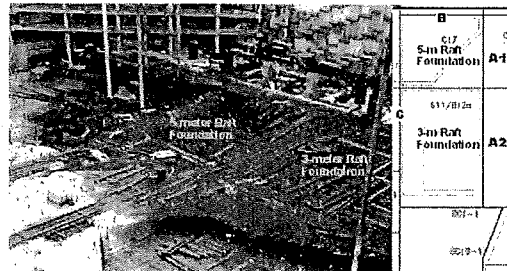
Diagram 2:  
General snapshot of the collapsed region and location in the plan

On the day of the accident, workers were installing re-inforcement bars for the foundation at the basement. The re-inforcement bars were supported by U-shape bar chairs. Halfway through the erection, the bar-chair support system collapsed.

Investigation revealed that the bar chairs had "toppled over". The system wide collapse was triggered by a localized failure of the bar chairs at a particular area. Investigation also revealed that the design of the bar chairs did not provide for any bracing or anchoring to serve as restraint against any horizontal force that could be exerted onto the bar chairs.
