RECORD OF INVESTIGATION INTO DEATH

Ref No: 47/04

*I, Alastair Neil Hope, State Coroner, having investigated the death of **Judith Lesley Ward and Lorraine Melia**, with an Inquest held at Albany Court House, Stirling Street, Albany on 7-16 December, 2004 and 24 January – 3 February, 2005 find that the identity of the deceased person was **Judith Lesley Ward and Lorraine Melia** and that death occurred on 27 December, 2003 at Taripta Farm, Lunt Road, Tenterden. Judith Lesley Ward died as a result of Thermal Injury and Lorraine Melia died as a result of Smoke Inhalation followed by Thermal Injury in the following circumstances –*

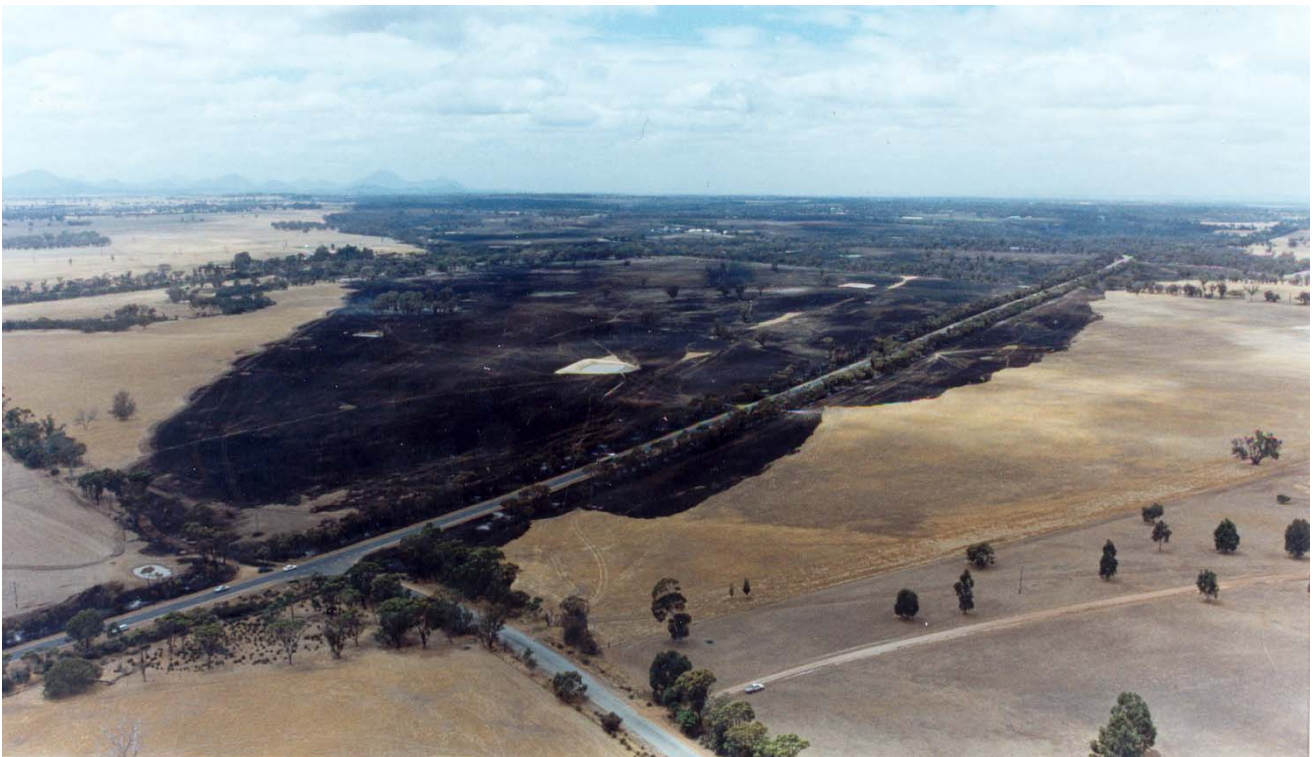
The above photograph taken by police depicts the fire scene from its starting location at poles CB721 and CB722

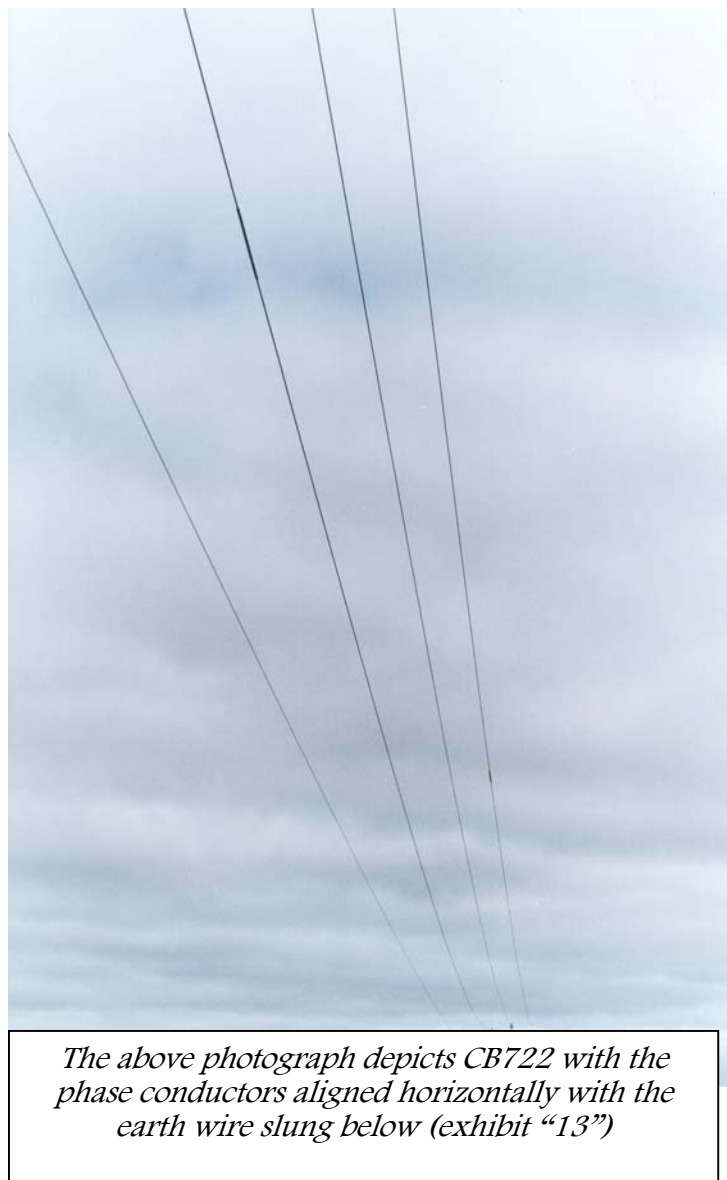
At pole CB722 the phase conductors had been aligned horizontally, with the earth conductor below, but at CB721 the conductors were aligned

The above photograph depicts CB722 with the phase conductors aligned horizontally with the earth wire slung below (exhibit "13")

vertically (a running disc angle). The reason for the change from horizontal to vertical alignment was to allow for a change in the direction of the powerline at CB721.

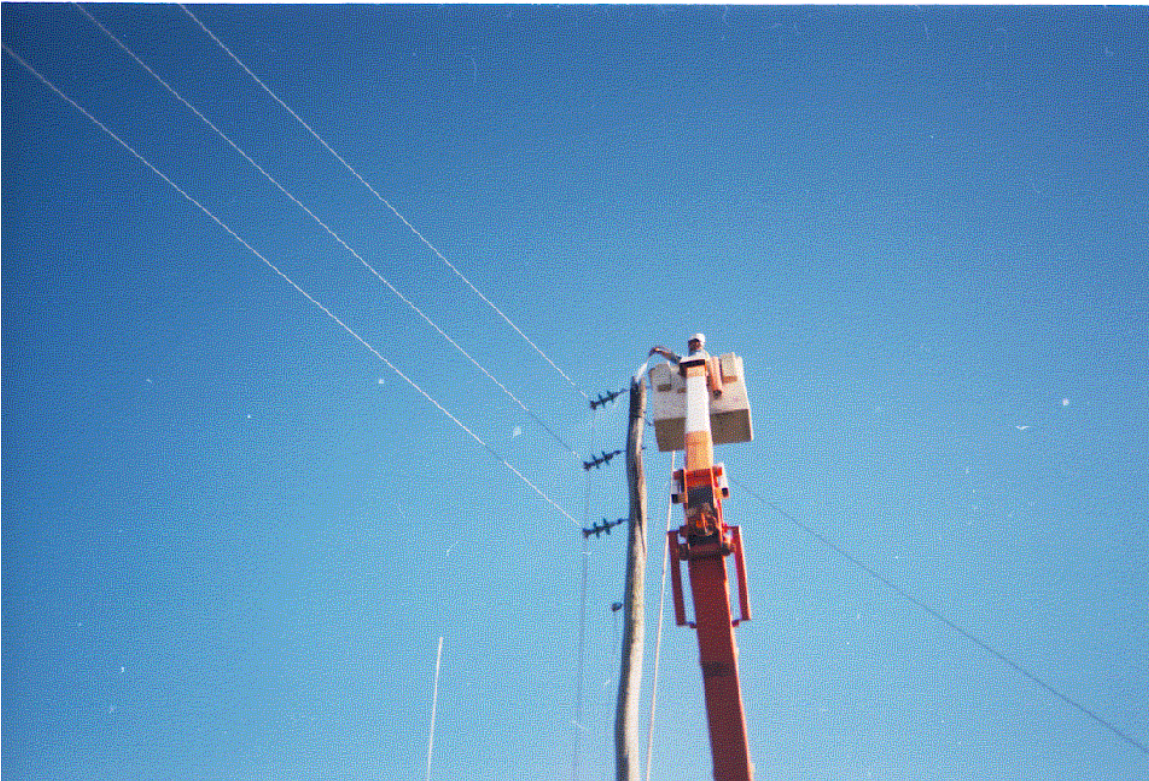
The fault was caused by the live red phase conductor and the underslung earth wire coming together due to erratic movement of both wires in strong gusting wind and high ambient air temperature. When the two live bare conductors came together they caused an arc to develop across a small air gap between them or at the a point of actual contact. As a result molten hot metal globules fell to the ground and provided a source of ignition to dry stubble (Electrical Incident Report prepared by the Energy Safety Division, Department of Consumer and Employment Protection (Energy Safety) exhibit "2"). Subsequent examination of the conductors between the poles indicated that there were electric arc burn marks on the aluminium of the conductor on the center phase and also on the underslung earth wire which had subsequently broken and had been immediately below it.

The above photograph (no. 1 of exhibit “45”) depicts power pole CB721 taken on the afternoon of 27 December, 2003. The pole top had been on fire and Western Power employee Carl Weinert is in the process of extinguishing the fire, photograph taken by Alan Wilson

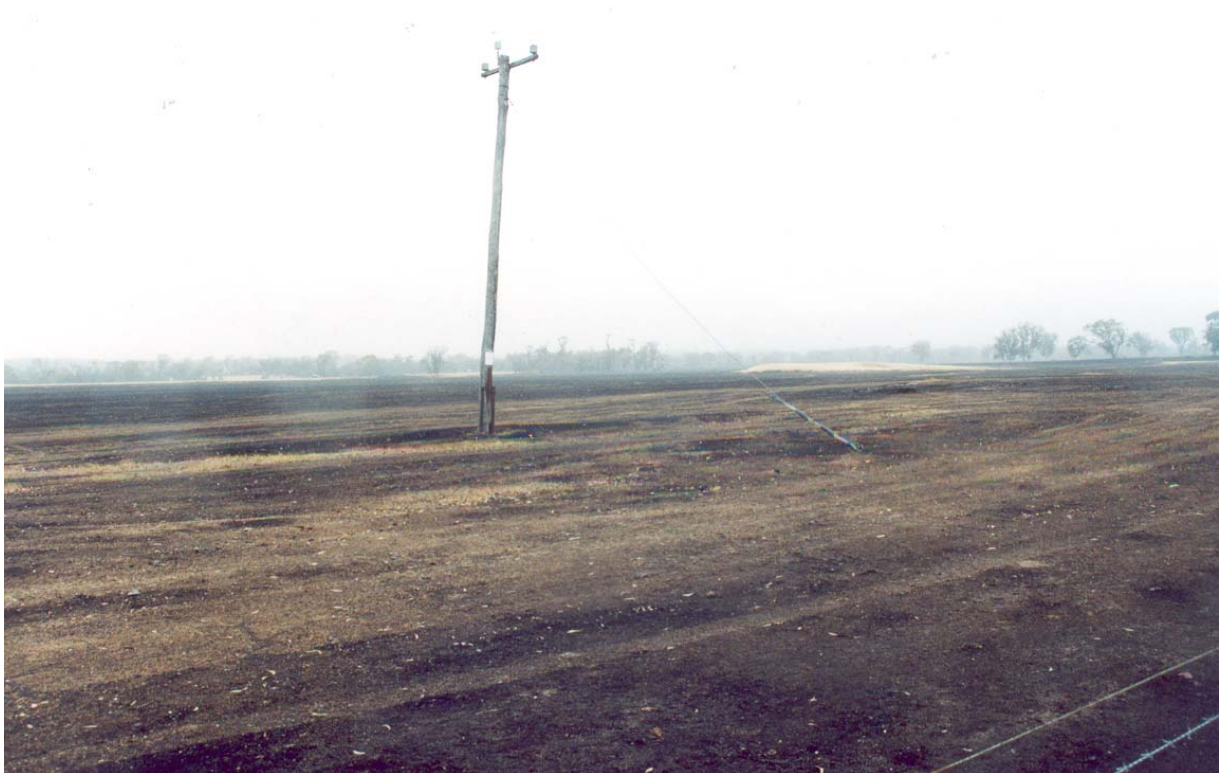
The above photograph depicts an example of Western Power pole leaning off vertical alignment. Support stay wire not tensioned. Pole and stay wire were not affected by recent fire. Pole located approximately 1 kilometre south of pole CB721. Exhibit "13"(25).

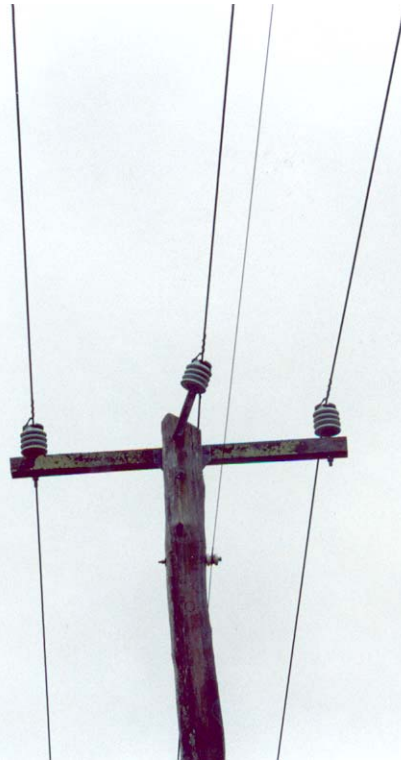
This photograph depicts an example of an insulator not securely fitted to the top of a Western Power pole. Pole located approximately 20 kilometres south of pole CB721. Exhibit "13"(26)

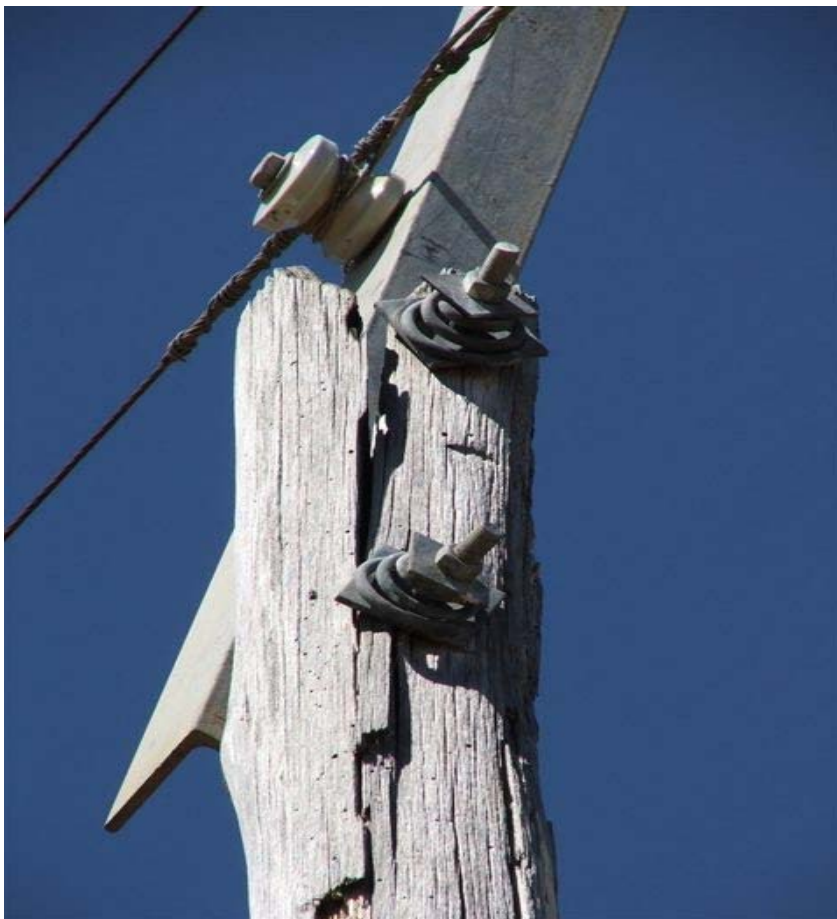
Kelvin Ridgeway, during the course of the inquest itself. Mr Ridgeway's photographs depicted a power pole on his farm, the galvanised angle iron top supporting the insulators on the pole can be seen tilting over as a result of degeneration of the wood.

The above photograph is one of the photographs taken on the Ridgeway farm and depicts a split pole inadequately supporting angle iron and conductors (part of exhibit "28").
