FINDING OF INQUEST

An Inquest taken on behalf of our Sovereign Lady the Queen at Adelaide and Whyalla in the State of South Australia, and Ada, Oklahoma and New York City, New York in the United States of America, on the 22nd July to 5th August 2002, the 26th August to 3rd October 2002, the 23rd to 30th October 2002, the 11th November to 24th December 2002, the 3rd, 29th and 30th days of January 2003, the 14th and 28th days of February 2003 and the 24th day of July 2003, before Wayne Cromwell Chivell, a Coroner for the said State, concerning the deaths of Benjamin Kurt Mackiewicz, Joan Elizabeth Gibbons, Teresa Viola Pawlik, Wendy Ruth Olsen, Peter Desmond Olsen, Neil Marshall, Richard Deegan and the disappearance of Christopher James Schuppan.

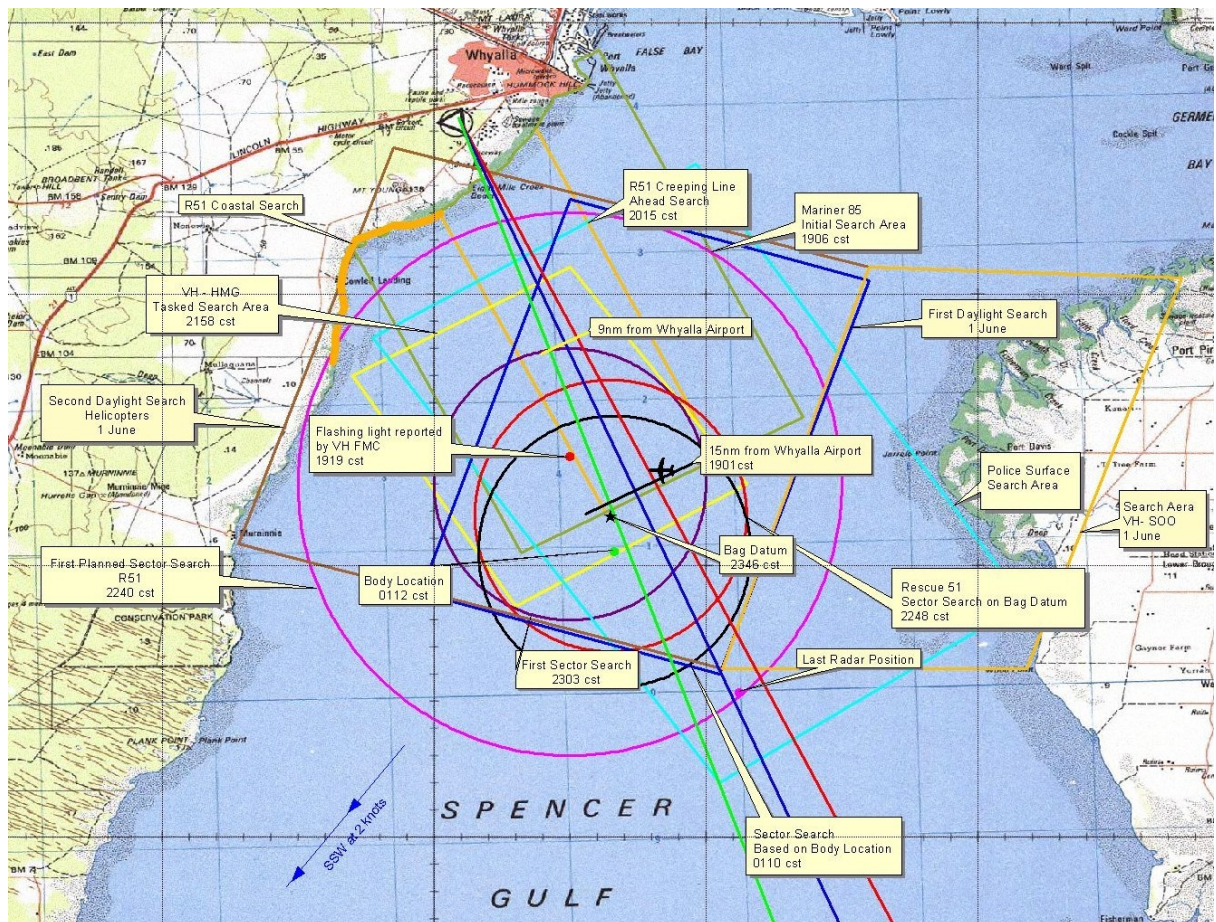
- 2.33. An analysis of the maps and diagrams tendered (Exhibits C119a&b, C115) discloses that on several occasions the search vessels passed over the site where the wreckage was eventually discovered, but no sign of it was found, and no further bodies were found in the water. On the next page is a map (Exhibit C115, slide 14) which illustrates the many different search areas covered:

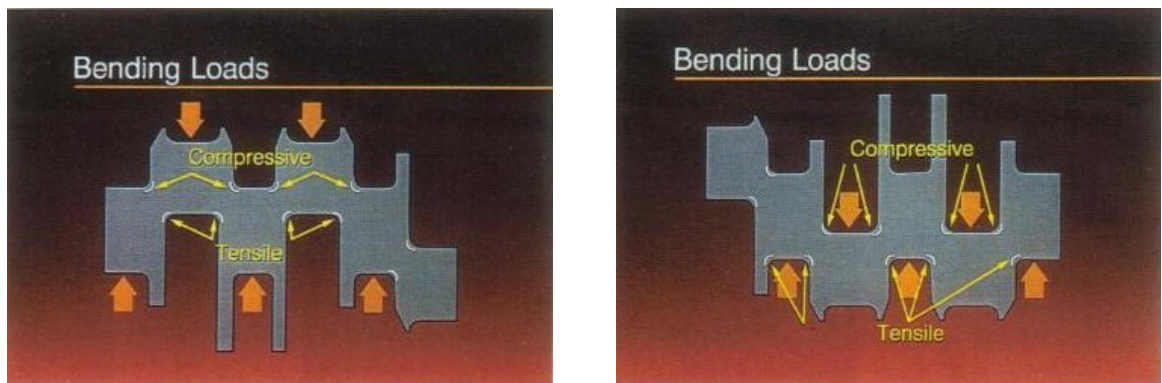
- 11.53. One area where there is serious controversy between the evidence of Mr Murphy and Dr Zockel is whether the fatigue crack would propagate when the crankshaft was in compression, according to Mr Murphy, or tension, according to Dr Zockel. Their respective opinions appear to revolve around whether the ‘cheeks’ or webs of the crankshaft surface would tend to flex, as illustrated by Mr Murphy (T2174), or whether the journal surface itself would flex into a slight ‘U’ shape under compression as suggested by Dr Zockel (T3465). Mr Murphy produced diagrams from the publication ‘Crankshafts-Applied Failure Analysis’ (Exhibit C177c) reproduced below:
