FINDING OF INQUEST

An Inquest taken on behalf of our Sovereign Lady the Queen at Adelaide in the State of South Australia, on the 18th and 24th days of December 2020, the 3rd, 17th, 18th, 19th, 22nd, 23rd, 24th, 25th and 26th days of February, the 1st, 2nd, 22nd, 23rd, 24th and 25th days of March, the 28th, 29th and 30th days of April, the 3rd, 4th, 17th, 18th, 19th and 27th days of May, the 15th and 25th days of June, the 6th day of August, the 7th and 9th days of September 2021 and the 7th day of June 2022, by the Coroner's Court of the said State, constituted of Ian Lansell White, Deputy State Coroner, into the death of Adelene Leong Yi Hui.

The said Court finds that Adelene Leong Yi Hui aged 8 years, late of Bukit Baru, 75150 Melaka, Malaysia, died at Women's and Children's Hospital, North Adelaide, South Australia on the 12th day of September 2014 as a result of multiple injuries. The said Court finds that the circumstances of her death were as follows:

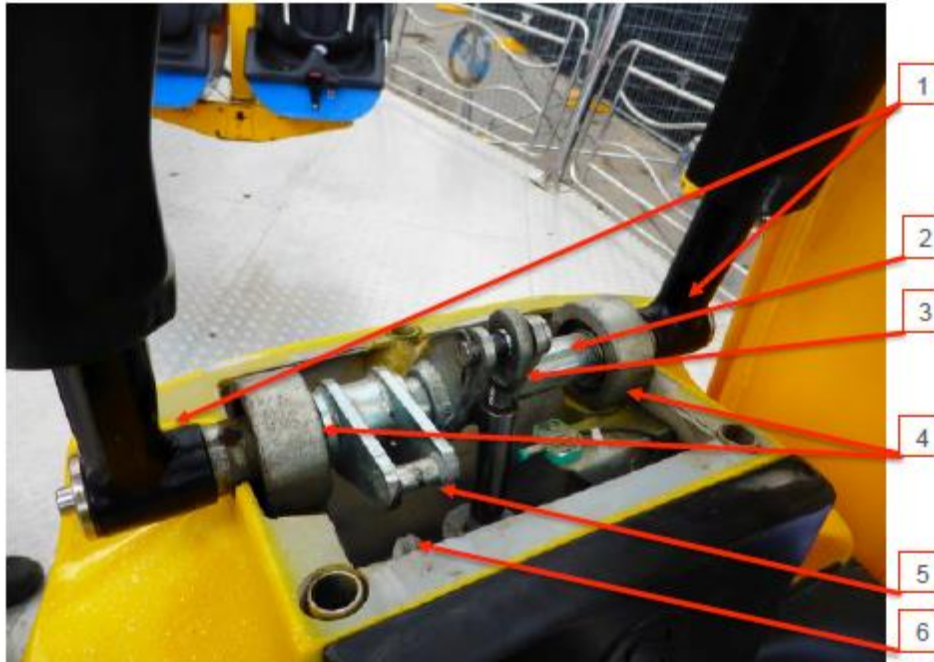
Figure 9 Airmaxx 360 Over the shoulder rigid harness connection point (P1010564.JPG)

13.15. Feature 3 of Figure 9 shows the connection of the primary lock cylinder²⁸⁵ to the common shaft. This was the key component to the PLS that operated based on hydraulic components assembled into a single unit. A further illustration of the PLS is shown below in Figure 17 which demonstrated its position with respect to the harness and the unmarked SLS.²⁸⁶

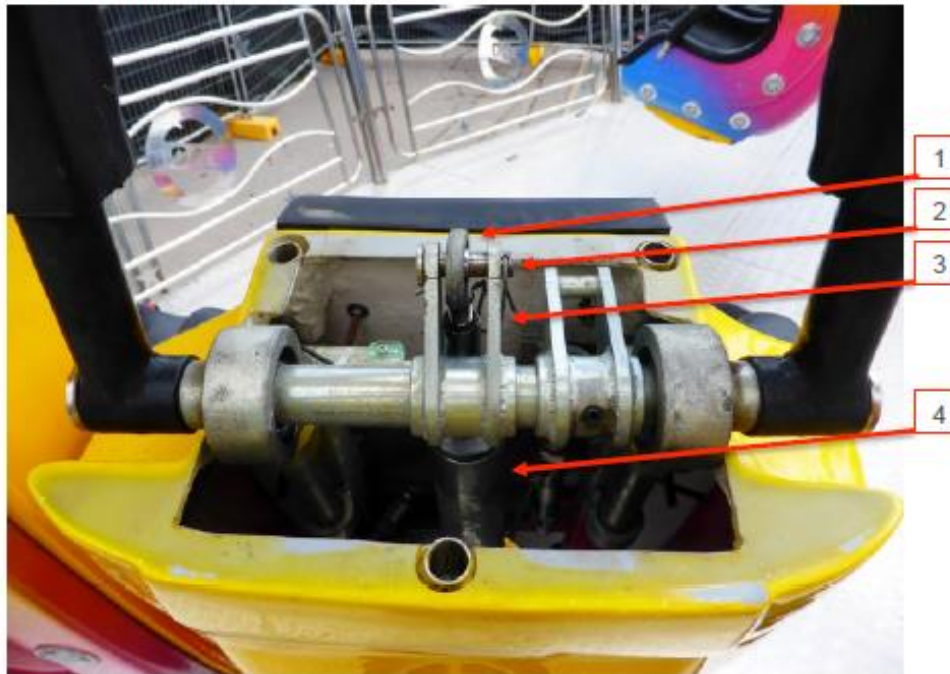
Figure 17 Airmaxx 360 Primary lock system connection (P1010565.JPG)

The primary lock cylinder is connected to the restraint harness via an arm that is mounted on the common shaft located at the back of each seat. This shaft is splined to prevent slippage at the connection point. Therefore ensuring the orientation of the primary lock system arm maintains its relative orientation to the restraint harness.

This worked on what is known as the '*trapped fluid*' principle described by Mr Kroon immediately above in Figure 17. That is, hydraulic fluid, not being compressible gets trapped at one end of the PL cylinder which forms a barrier preventing further movement in that direction.

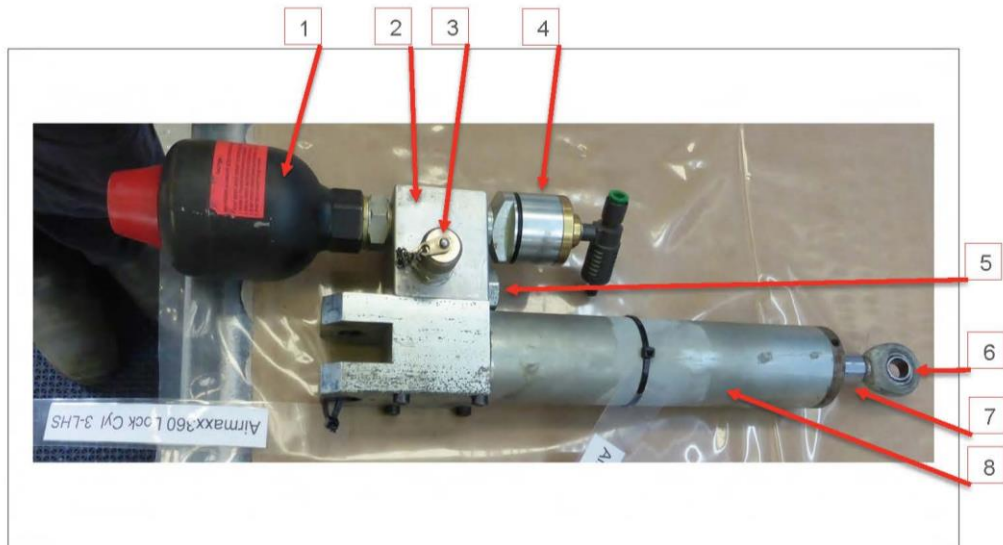
Figure 12 Primary lock cylinder with key components labelled (P1010827.JPG extract)

13.24. As Figure 17 of Mr Kroon's report²⁹¹ showed in paragraph 13.13, the PL cylinder's sole connection to the common shaft is at the midpoint.²⁹² It is a threaded connection.

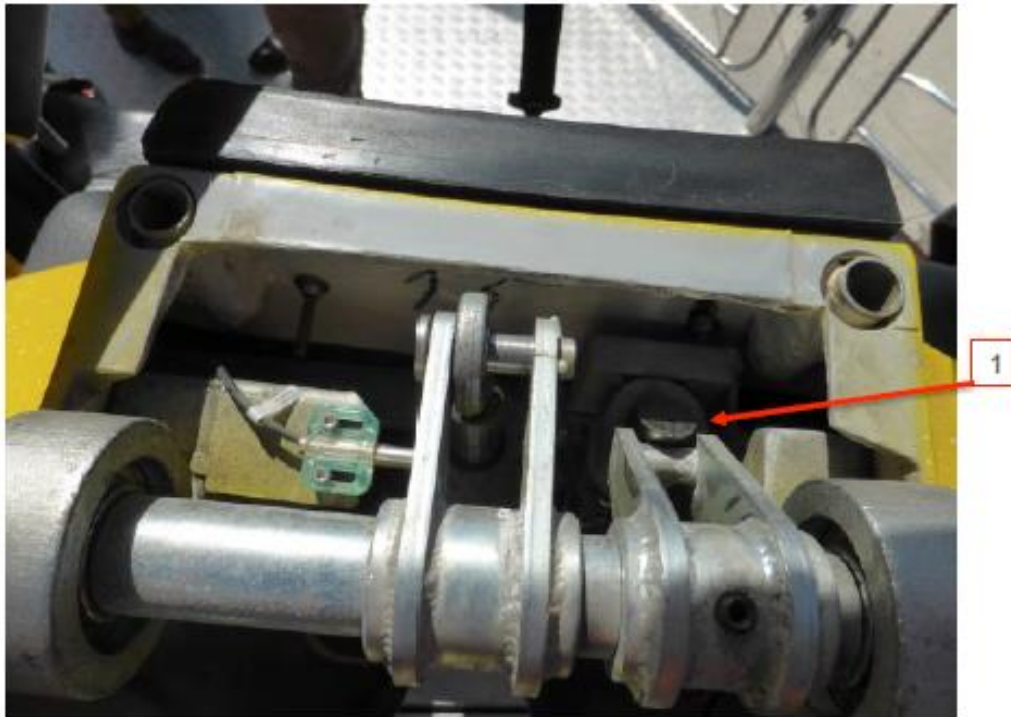
Figure 20 Airmaxx 360 Secondary lock system engaged (P1010282.JPG)

In Figure 20 the secondary lock system arm is engaged with the stop pin preventing the restraint harness from rising further. This is highlighted by arrow 1.

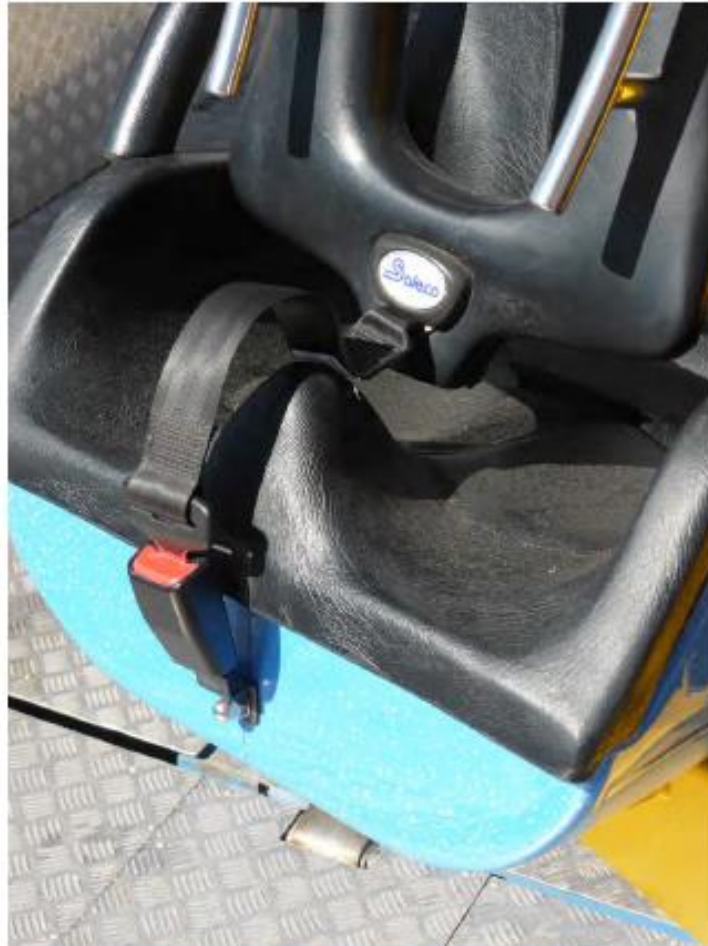
Figure 22 Airmaxx 360 Latching crotch belt restraint (P1010251.JPG)

The latching crotch belt can be seen in Figure 22 below which Mr Kroon described as *'similar to a car seat belt with one end fixed to the restraint harness and the other to the front of the seat'*.³¹⁹

The term "latching" in AS3533.1:2009 [Ref 10] is used where the patron can release the restraint. Whereas "locking" is used where the restraint can only be unlocked by the operator.

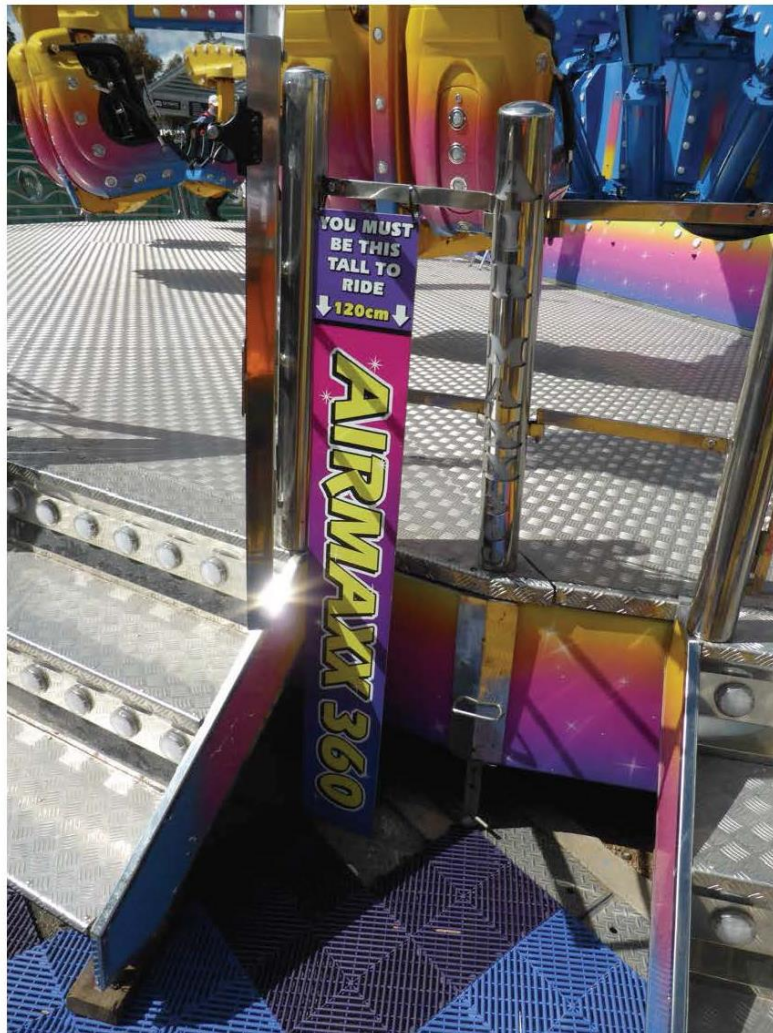
Figure 11 Airmaxx 360 Minimum height board (P1010275.JPG)

- 15.3. In order to understand the context in which the minimum height was set at 120cm for The Show, consideration must be given to each of the points in time prior to The Show when the appropriate minimum height for riders of the Airmaxx was considered by the manufacturers, the owners, experts and regulators.
- 15.4. There is no doubt that those involved in the amusement industry, including Ms Sullivan and Mr Watkins, were of the understanding that the minimum height of patrons permitted on a ride was set by the manufacturer of the ride. It was undoubtedly prudent for CJS to have known the exact details of Safeco's recommendations about the minimum height of patrons.
