CORONERS' FINDINGS

ROAD DEATH 18 OF 2024

I, Elisabeth Armitage, Coroner, having investigated the death of a **29-YEAR-OLD CAUCASIAN FEMALE** and without holding an inquest, find that she was born on **18 March 1995** and that her **death occurred on 29 March 2024, at Melville Bay Road, Nhulunbuy in the Northern Territory.**

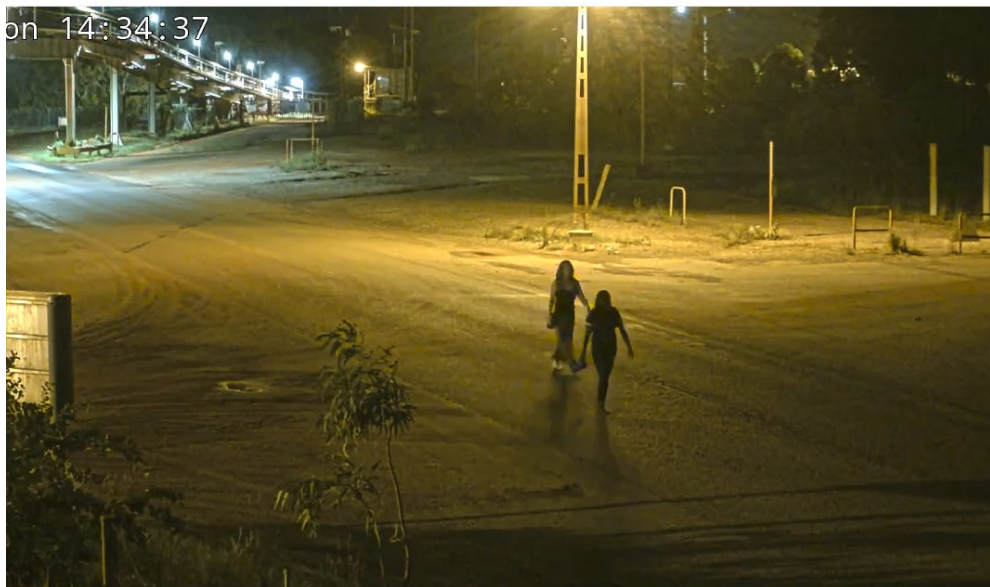
Still taken from CCTV, the deceased, and her friend walking down the road near the Rio Tinto conveyor

Just before 12.24am, the 29-year-old was now walking inbound (in the direction of Nhulunbuy) in the inbound lane while her girlfriend was slightly ahead of her and still walking on the edge of the outbound lane. There was no street lighting, and it was very dark. Witnesses described the lighting as "really bad along that stretch." The girlfriend used her phone torch to see, but the 29-year-old did not use any light. The 29-year-old was wearing darkish pants and a dark singlet.

The second recommendation fits in the Safe System approach. As it is now known that patrons (including intoxicated patrons) may attempt to walk from the Gove Boat Club towards Nhulunbuy, there should be adequate street lighting to reduce the risk to those pedestrians and other road users.

I recommend to the Department of Logistics and Infrastructure, that, together with RIO Tinto, they ensure that adequate street lighting be provided between the Gove Boat Club and Nhulunbuy to reduce the risk to pedestrians. The extent of the additional lighting is to be determined considering the known risks and the intent of the Safe System approach in the 2024-2028 Towards Zero Safety Action Plan.

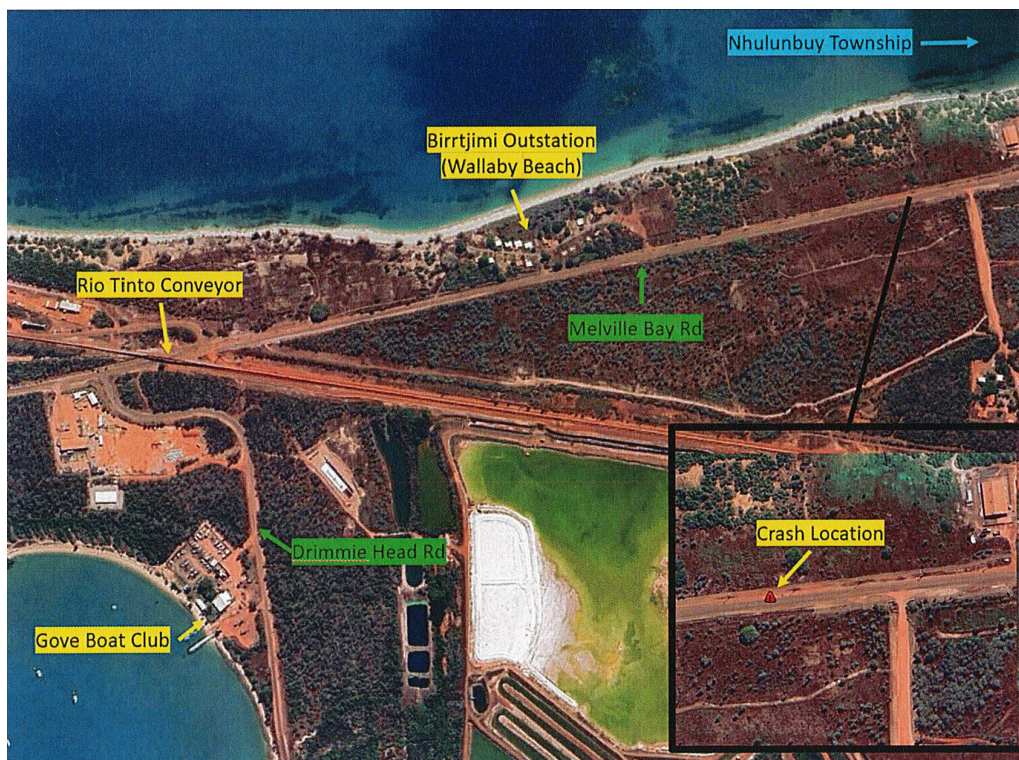
Crash location, Google Earth Image, and Police Investigators markings

The collision occurred on a straight sealed section of Melville Bay Road approximately 750 metres east of Wallaby Beach Outstation. The in-and-outbound lanes are delineated with a broken white centre line and there was no painted fog lane marking the road edges. The road has cleared, gravel shoulders with a row of steel power poles and a footpath running parallel with it on the north side of the road. The speed limit for that section of Melville Bay Road is 80 km/h.
