IN THE CORONERS' COURT OF THE NORTHERN TERRITORY OF AUSTRALIA

CORONERS FINDINGS
ROAD DEATH 52 OF 2024
Section 34 of the Coroners Act 1993

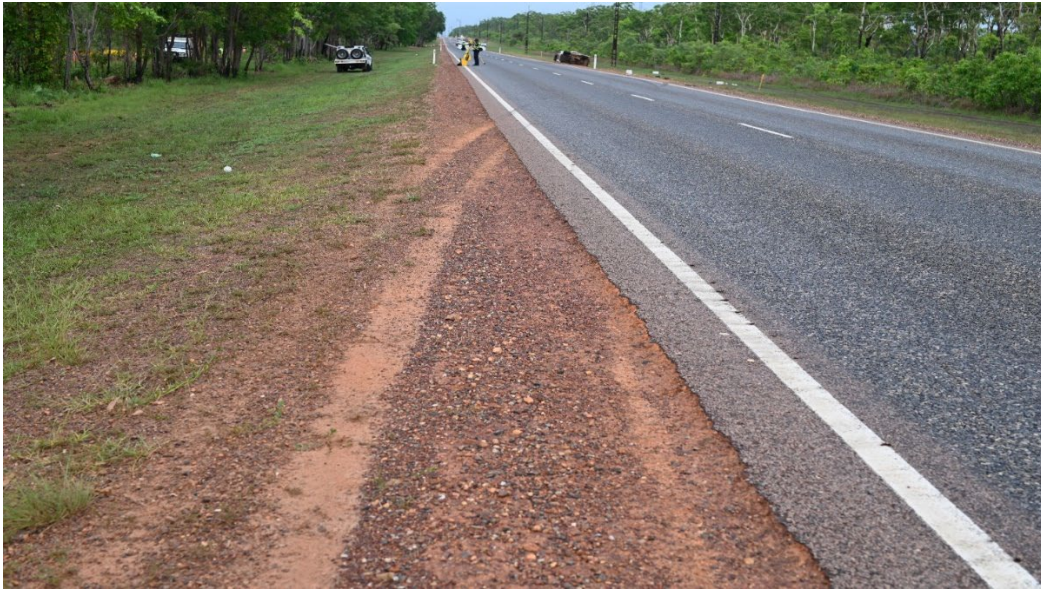
On Channel Island Road, 575 meters from the Bladin Village entrance, she veered off the left side of the road before entering a clockwise yaw. The Mitsubishi Pajero crossed the road entering an anticlockwise yaw before tripping and rolling approximately 80 metres, spreading debris along the roads edge. The Mitsubishi Pajero came to rest on its left side after sustaining extensive damage.

Selected scene photograph courtesy of Officer in Charge
