FINDING OF INQUEST

An Inquest taken on behalf of our Sovereign Lady the Queen at Adelaide in the State of South Australia, on the 1st, 2nd, 3rd, 4th and 24th days of September 2009 and the 27th day October 2009, by the Coroner's Court of the said State, constituted of Anthony Ernest Schapel, Deputy State Coroner, into the death of John Eric Mitchell and Graham Bryant.

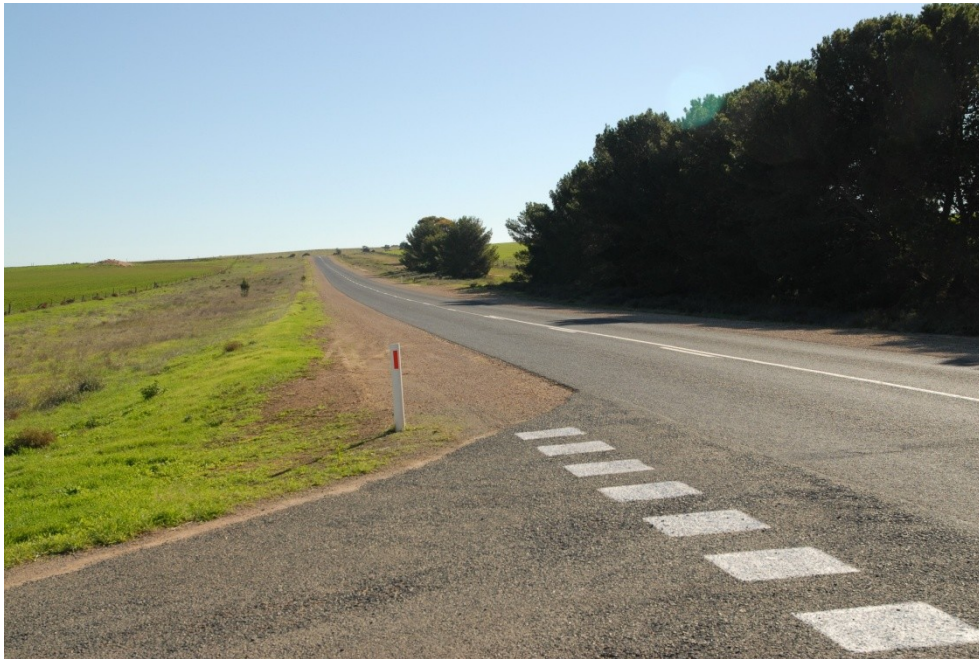
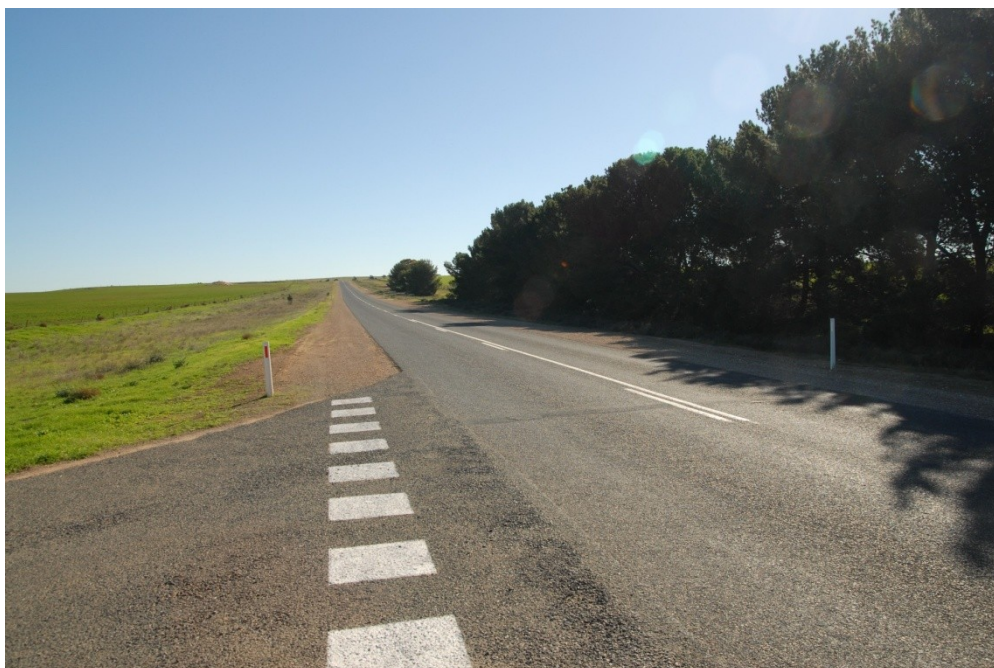
shadows thrown across the eastern carriageway in which Mr Bryant's motorcycle was travelling are minimal, except within the confines of the intersection itself. However, we are only concerned with what Mrs Thiele saw or failed to see before Mr Bryant actually reached the intersection. Far from demonstrating that Mr Bryant's motorcycle would have been obscured by shadow, there is very little evidence of shadow. What is shown is minimal and patchy and could not possibly have hidden from view even a dark coloured motorcycle being ridden at a speed that was not in excess of the limit. Two of Brevet Sergeant Keir's photographs are depicted below.

It is worthwhile observing that when Mrs Thiele was shown one of the photographs that were taken by Brevet Sergeant Keir²⁷ she was surprised to learn that it had been taken at the same time as the Bryant collision and at the same time of the year. She agreed that the photograph demonstrated that the trees did not in fact cast a great shadow over the road²⁸.

- 5.10. As to the question of the camouflaging of Mr Bryant's dark clothing and motorcycle against the trees, in my view a person with ordinary powers of observation, good eyesight, with a proper lookout and endeavouring to identify whether there was any traffic present, should have seen Mr Bryant's motorcycle notwithstanding the trees. Roadside trees and vegetation are but one feature of the landscape that a motorist should instinctively take into account when ascertaining the presence of traffic. It is difficult to see how a failure to identify the presence of traffic can in any way be mitigated by the background against which the traffic might be seen when there is a clear duty upon a motorist to keep a proper lookout for the presence of traffic and to adjust one's driving behaviour according to the conditions. Even if one were to accept that Mr Bryant's dark motorcycle would have been less visible against a background of dark trees than say that of a yellow canola crop, it was nevertheless visible.

- 5.11. In short, I do not see how the presence of the trees, either by way of shadow or camouflaging, could in any way explain away or mitigate Mrs Thiele's failure to keep a proper lookout.
